To Restore or Not to Restore; That is the McQuestion

Michele Tremblay

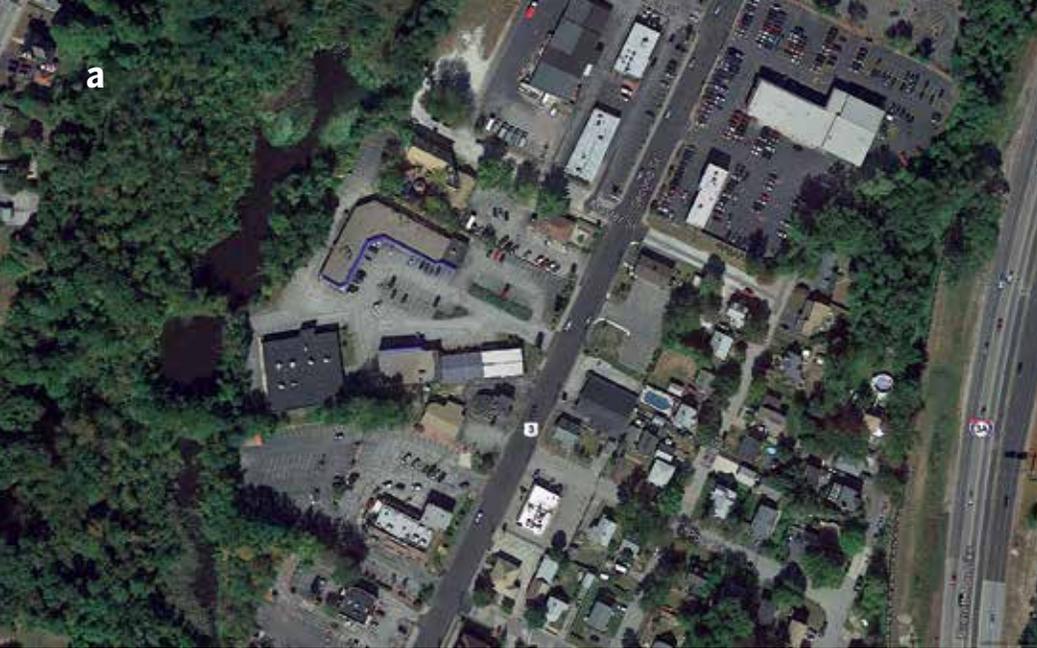
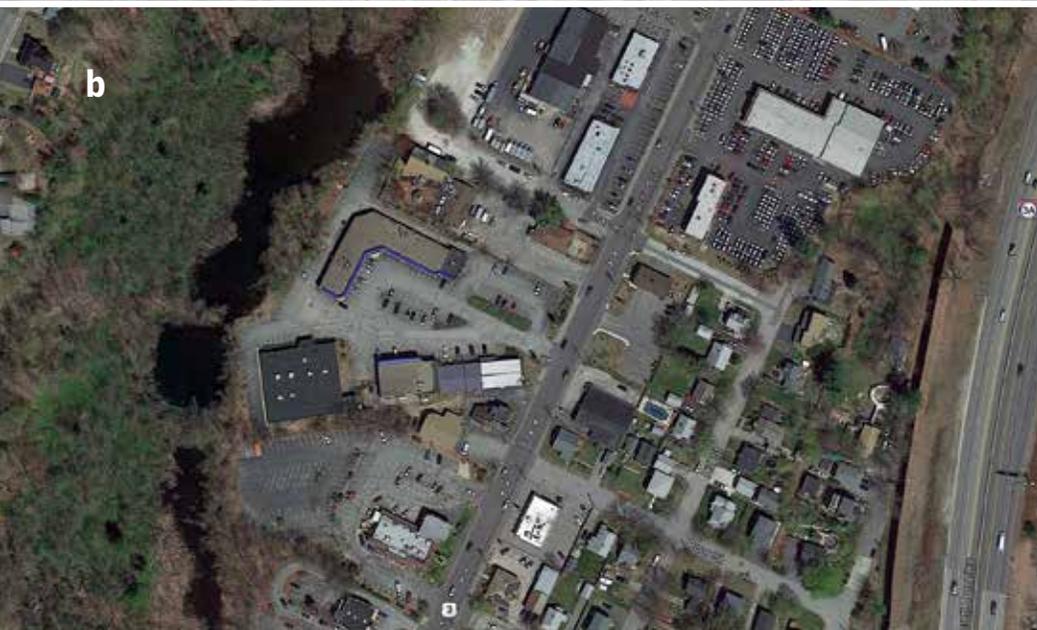
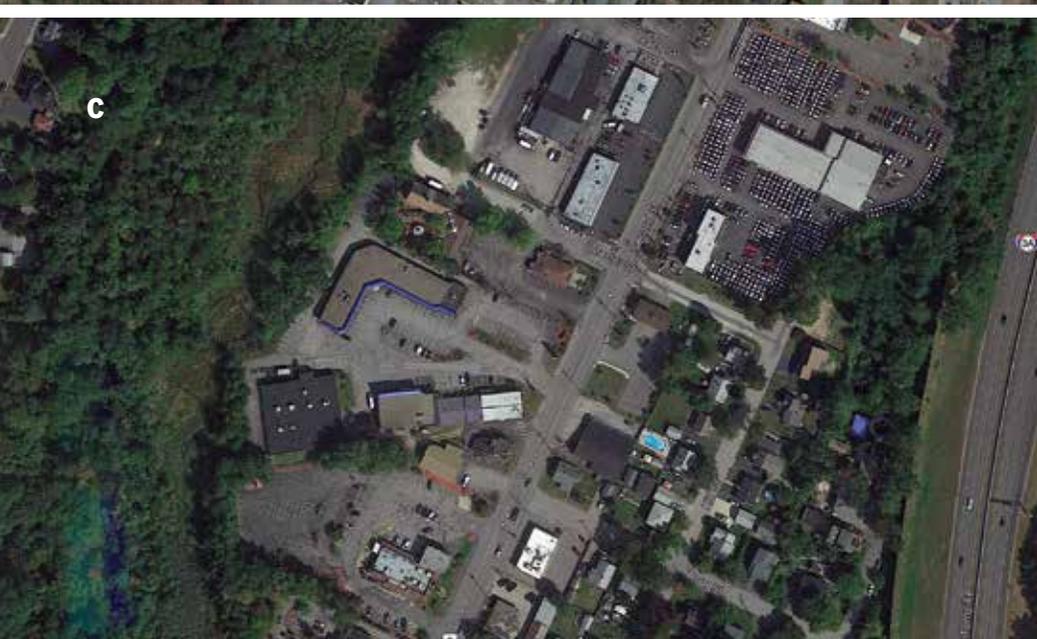
Figure 1 a-c. Google Earth images of McQuesten Ponds over time.

and local businesses, galvanized the planning efforts to restore the McQuesten watershed – a third of which is covered by impervious surfaces (Figure 1a-c).

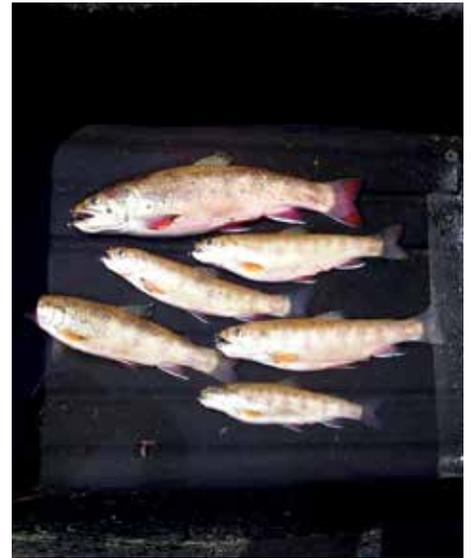
Figure 2. Eastern brook trout were found dead behind the impoundment on the main tributary to McQuesten Brook.

The story of McQuesten Pond or, more accurately “ponds,” has nothing to do with the brook and everything to do with an urban planning vision. Early on, the City of Manchester envisioned the land along the tributary as a residential area. “Paper roads” were created on maps. Piles of rocks, concrete, and granite curb fragments were brought to the area as placeholders and became three causeways across the tributary, which were functioning as dams and creating a series of ponds. On the brook's mainstem, an impressive do-it-yourself dam was built with cinder blocks and stuccoed with concrete at the outlet of a nearly 8,000-foot long culvert carrying the brook underneath neighborhoods. The dam impounded not only water but an array of debris. It was there that the eastern native brook trout were trapped and died (Figure 2). It was dubbed the “fish killer dam,” and everyone agreed its days were numbered.

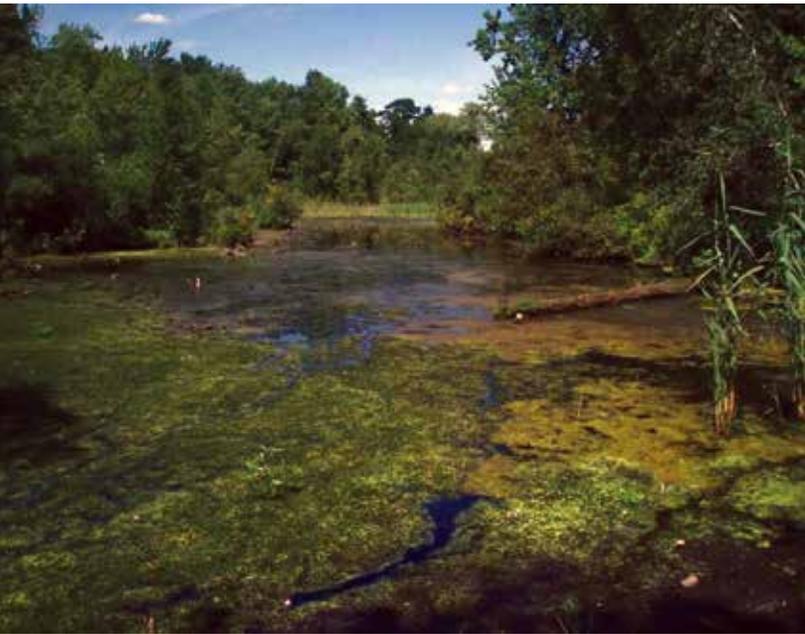
Figure 3. The uppermost and main McQuesten Pond was choked with algae for most of the year.

over a dozen feet of sediment in the impoundments. The tree canopy that once shaded the tributary withered and died in the impoundments. Water temperatures rose, oxygen plummeted, and the pond became shallow and choked with algae (Figure 3). While some area residents cared about the pond area, others treated it as a dumping ground. Snow was plowed from the “riparian” parking lots taking with it dumpster overflow, shopping carts, shipping pallets, bottles, cans, and an amazing array of discarded items including construction waste, furniture, a coffin wagon, and a four-foot-tall stuffed crab. For over a decade, leading up to the dams de-construction and culvert removals in the summer of 2016, McQuesten Pond failed to meet designated uses supporting aquatic life and primary contact recreation. The impoundments were always full and did not allow for flood storage. Businesses and area residents were flooded regularly during even small storms. McQuesten Brook had lost its way.

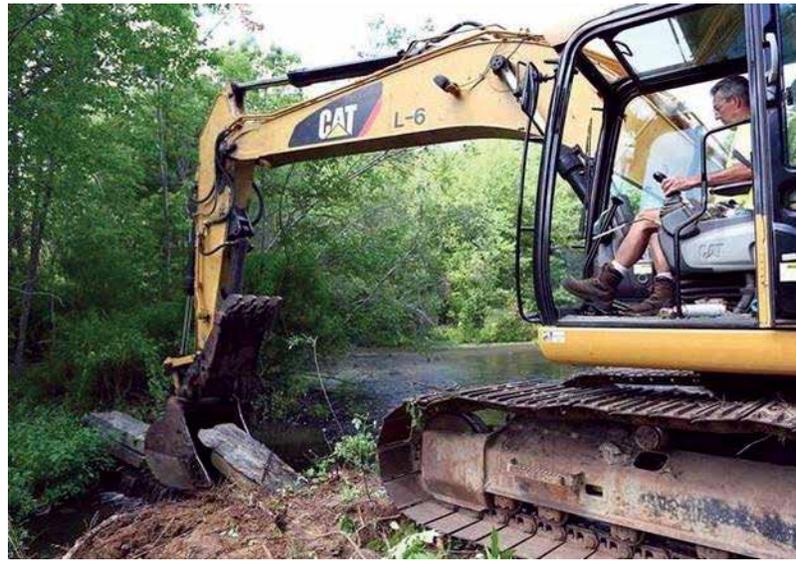
Figure 4. A member of the Manchester Department of Public Works removing the obstruction that formed the main McQuesten Pond

The City's Department of Public Works crews gathered one morning in 2016 with volunteers in the heat of high summer to remove the Fish Killer Dam. Area homeowners provided access to the steep site through their backyards to allow for compressed air hoses to snake down the steep banks from generators. With two jackhammers and hand tools, the dam was removed just after midday. Several volunteers were dispatched to Taco Bell for take-away food while others continued to clean up the first site. City crews left the site to deploy heavy equipment to the three tributary dams. Within a week, all of the dams were removed (Figure 4).

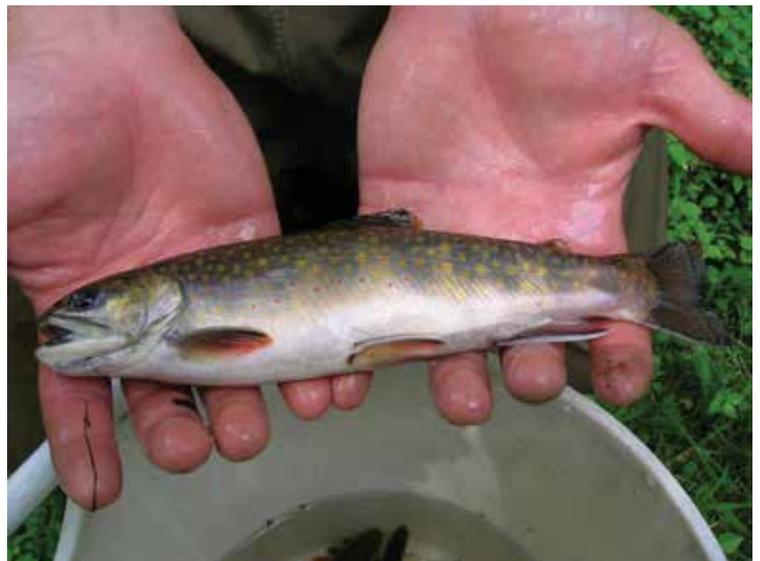
Figure 5. Mature, healthy eastern native brook trout.

The eastern native brook trout size and population density in this urban area has rivaled that of those found in pristine mountain streams in New Hampshire. The dam and debris that trapped and killed the fish is removed and they now move freely through the cool waters of the mainstem and tributary. They thrive and reproduce naturally with no stocking intervention (Figure 5).

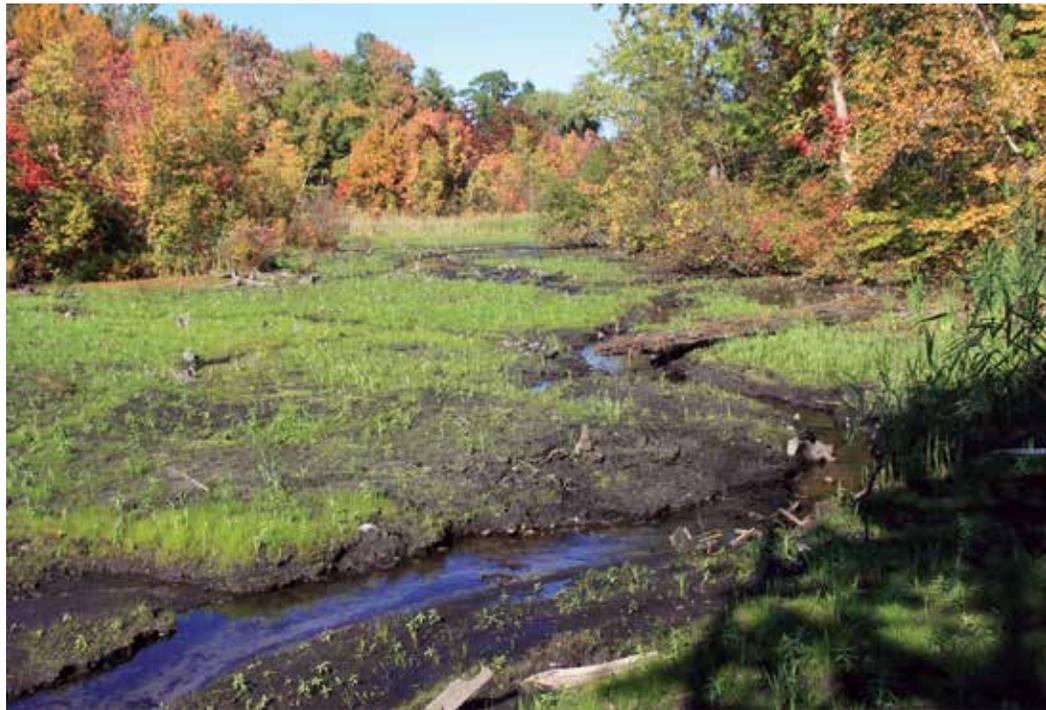
Figure 6a. The former uppermost and main McQuesten Pond during the autumn after the dam removals. The brook is meandering with feeder stream and springs through the former impoundment areas.

McQuesten Brook is finding its way again with cool and oxygenated water from feeder streams and underground springs. Native tree, shrub, grass, and wildflower seeds buried under water for nearly seventy years are sprouting and growing lushly in the rich bottom sediments of former ponds (Figure 6a and 6b).

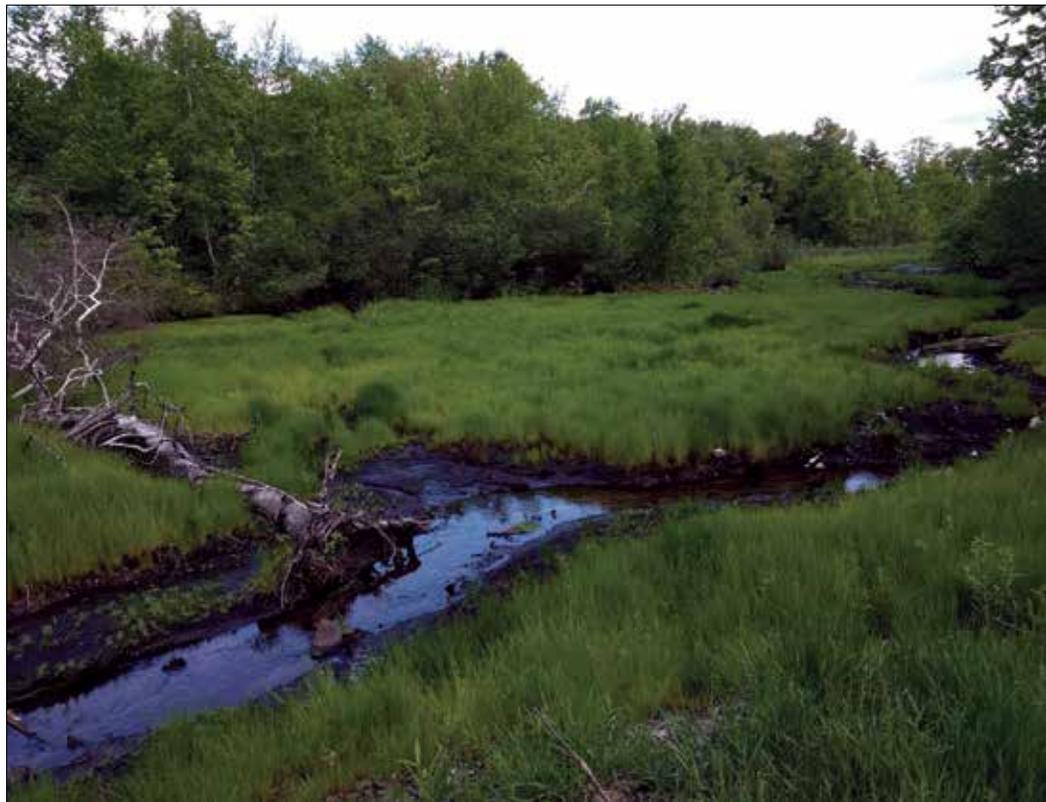
Figure 6b. McQuesten Brook finding its way again. The vegetation is sprouted from seeds buried under the impoundments for decades. Woody material was left on the site to provide natural habitat and stream flow regimes.
