**INDIVIDUAL INVENTORY FORM****NHDHR INVENTORY # MAN0487****Name, Location, Ownership**

1. Historic name B&MRR Goffstown Branch Bridge No. 1.89 over Piscataquog River a.k.a. Kelly's Falls Bridge

7. Current use(s) Closed, unsafe and barricaded bridge on recreational trail

9. Style steel stringers on wood pile bents

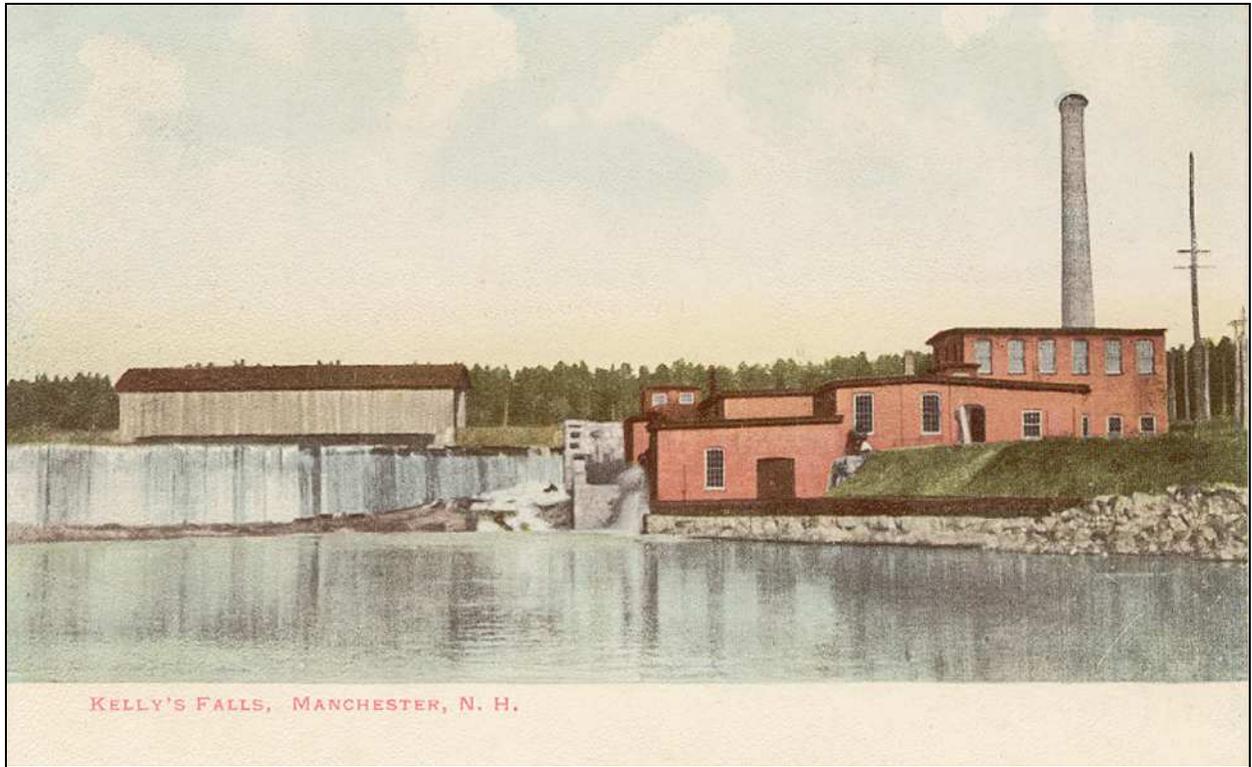
FIGURE 3: Kelly's Falls Dam and Hydroelectric Plant ca. 1890. B&MRR Piscataquog River Covered wood truss railroad bridge seen in background was destroyed by fire in 1941. Current trestle replaced it. (Source: Pinardsville History website)

By 1890 the line had come under the control of the rapidly expanding Boston & Maine Railroad system. That year (1890) the Union Electric Company erected the dam and powerhouse at Kelly's Falls, about 500 feet downstream of the railroad bridge (see Figure 3). The following history of the line in the early 20<sup>th</sup> century is taken from the NHDHR Area Form for the Goffstown Branch Railroad:

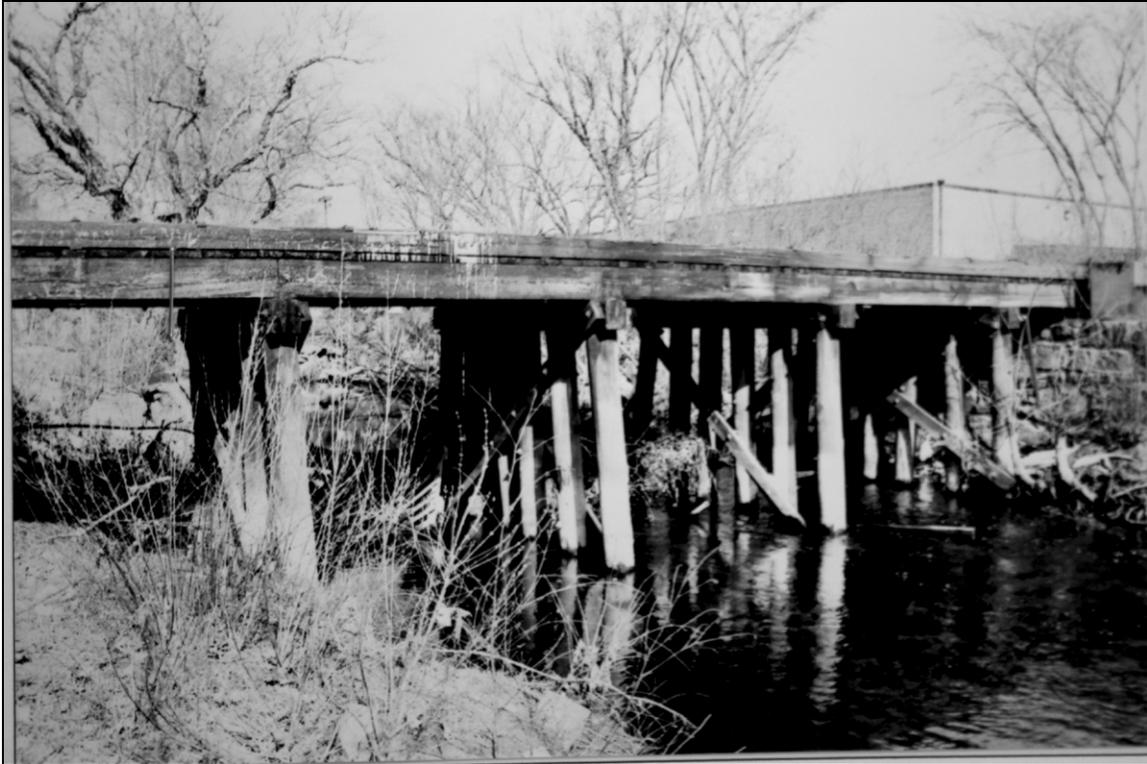
FIGURE 10: Comparative Bridge: Manchester-Lawrence RR Trestle 4.65 over Spickett River, Salem. Six span, with solid concrete deck, 65' long, built 1929. (Source: Manchester and Lawrence Railroad Area Form, Lisa Mausolf, 2009).

1) Manchester-Lawrence RR Trestle 4.65 over Spickett River, Salem is a six span solid-deck pile-bent trestle 65' long built in 1929 (see Figure 10). It differs from the Kelly's Falls Bridge with its solid concrete deck and lower height with only one set of bracing instead of two (the second set of bracing on the Kelly Falls Bridge is below the water surface).

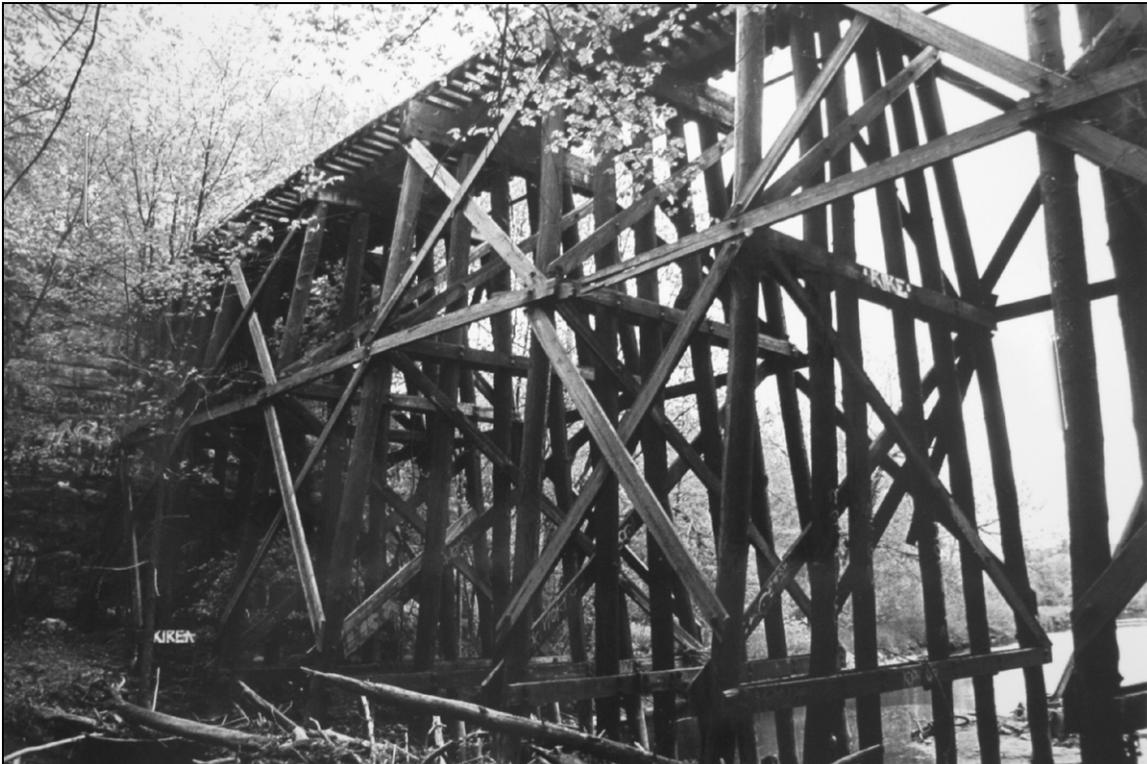
FIGURE 11: Comparative Bridge: Manchester-Lawrence RR Trestle 24.17 over Cohas brook, Manchester. Eight span, 154' long, built 1932 by B&MRR. Although not mentioned, spans appear to be steel I-beams. (Source: Manchester and Lawrence Railroad Area Form, Lisa Mausolf, 2009).

2) Manchester-Lawrence RR Trestle 24.17 over Cohas Brook, Manchester is an eight span, 154' long, braced-frame pile bent trestle built 1932 by B&MRR (see Figure 11). Although not mentioned in the Area Form description, the spans appear to be steel I-beams like those found on the Kelly's Falls Bridge; it is also a high structure with two sets of bracing on each bent. It differs in that it is a braced frame trestle with alternating upper and lower cross bracing between each bent.

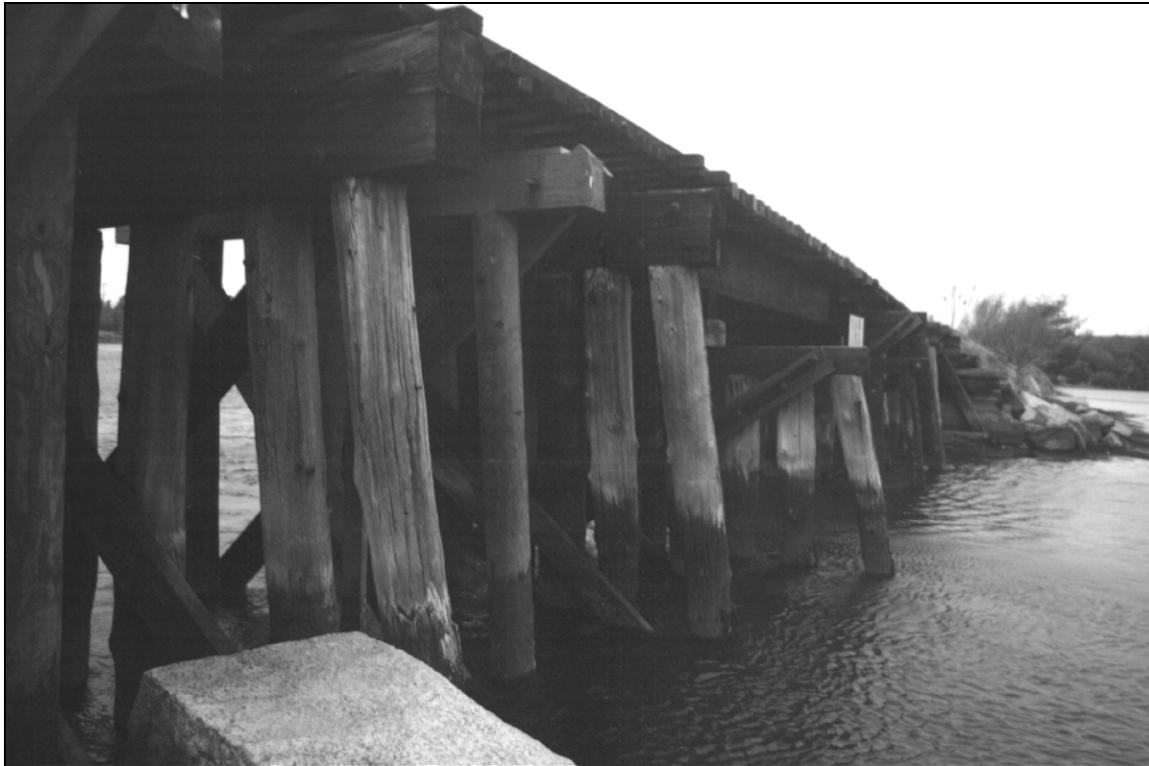
FIGURE 12: Comparative Bridge: Portsmouth-Dover RR Trestle MP 0.19 over Piscatqua Inlet, Portsmouth. Nine span, timber and I-beam spans, circa 1910 with later reconstruction. (Source: Newington Branch/Portsmouth & Dover Railroad Area Form, Lisa Mausolf, 2010).

3) Portsmouth-Dover RR Trestle MP 0.19 over Piscatqua Inlet, Portsmouth is a nine span pile bent trestle with both timber and I-beam spans, circa 1910 (see Figure 12). It is lower in height with only one set of bent bracing and less impressive in scale, but otherwise similar in design.

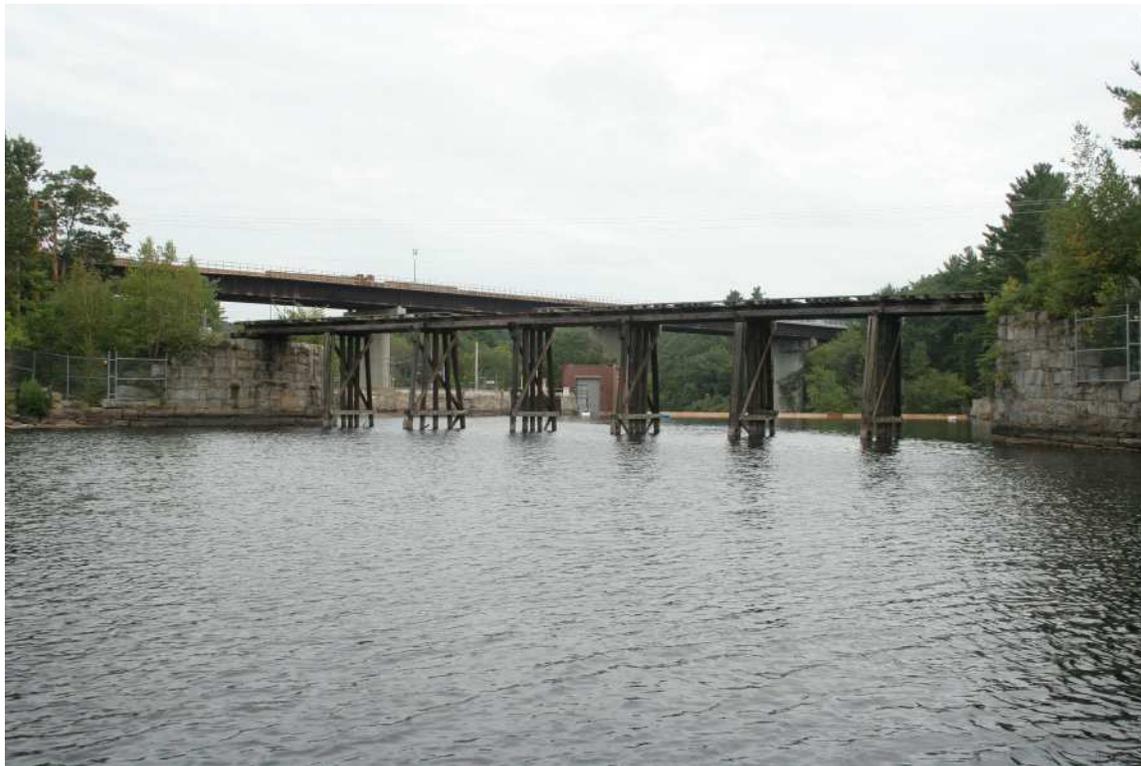
Photo # 2 description: View of north (upstream) side of bridge with Kelly St. bridge in background.

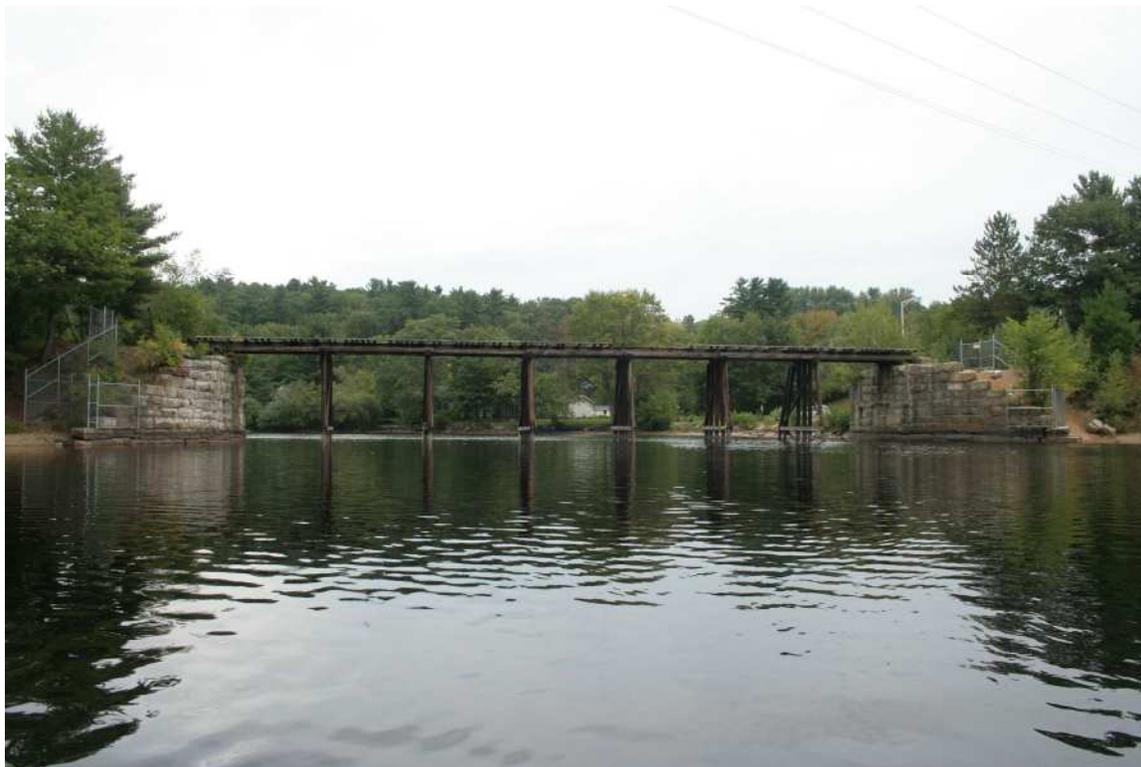
Photo # 3 description: Overall view of south (downstream side of bridge).

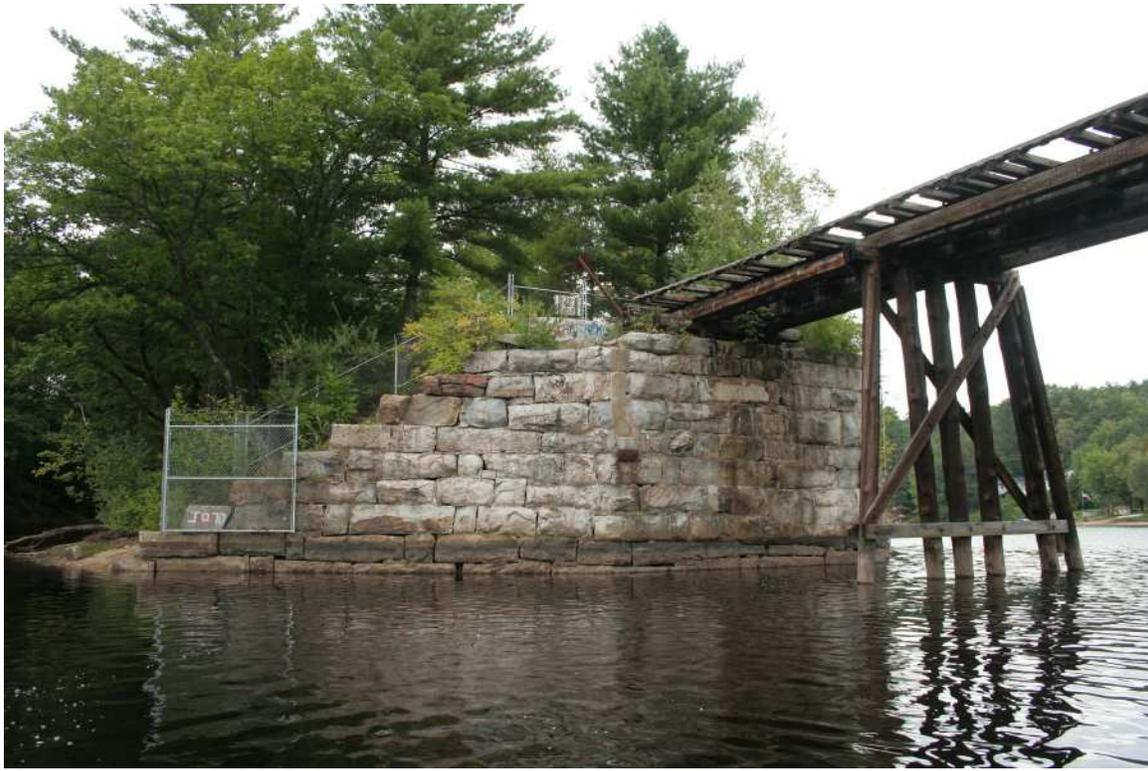
Photo # 4 description: South side of Goffstown abutment.

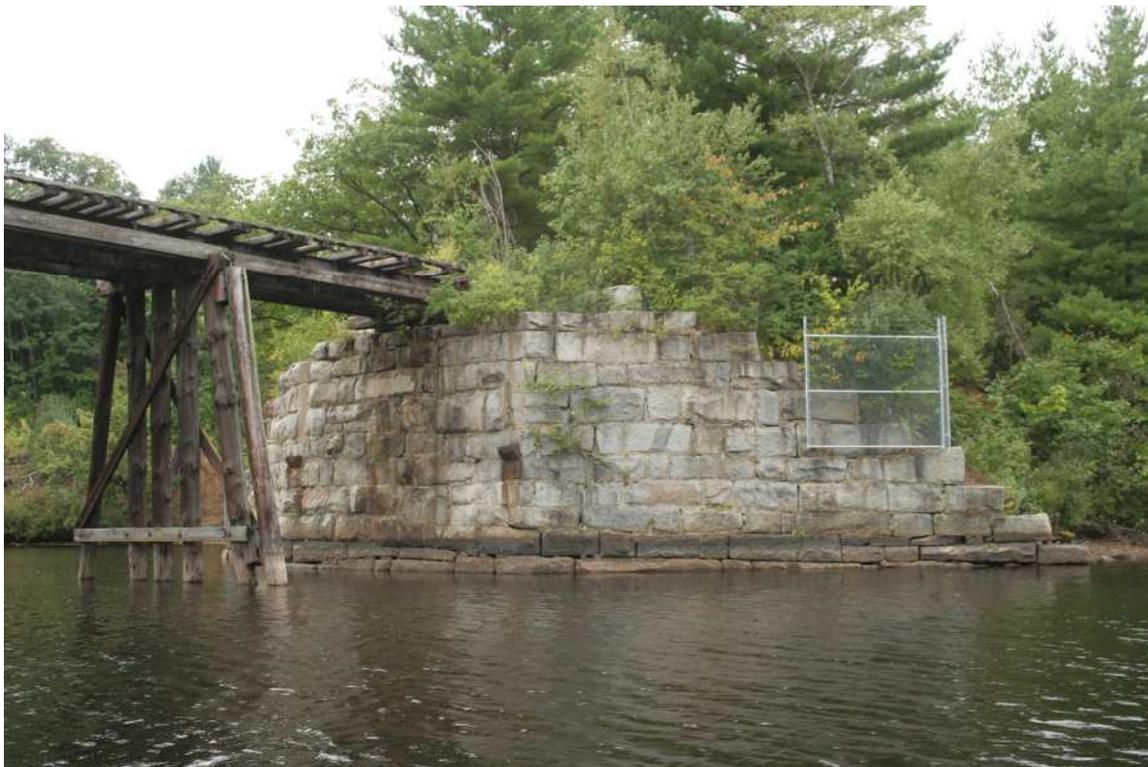
Photo # 5 description: North side of Goffstown abutment.

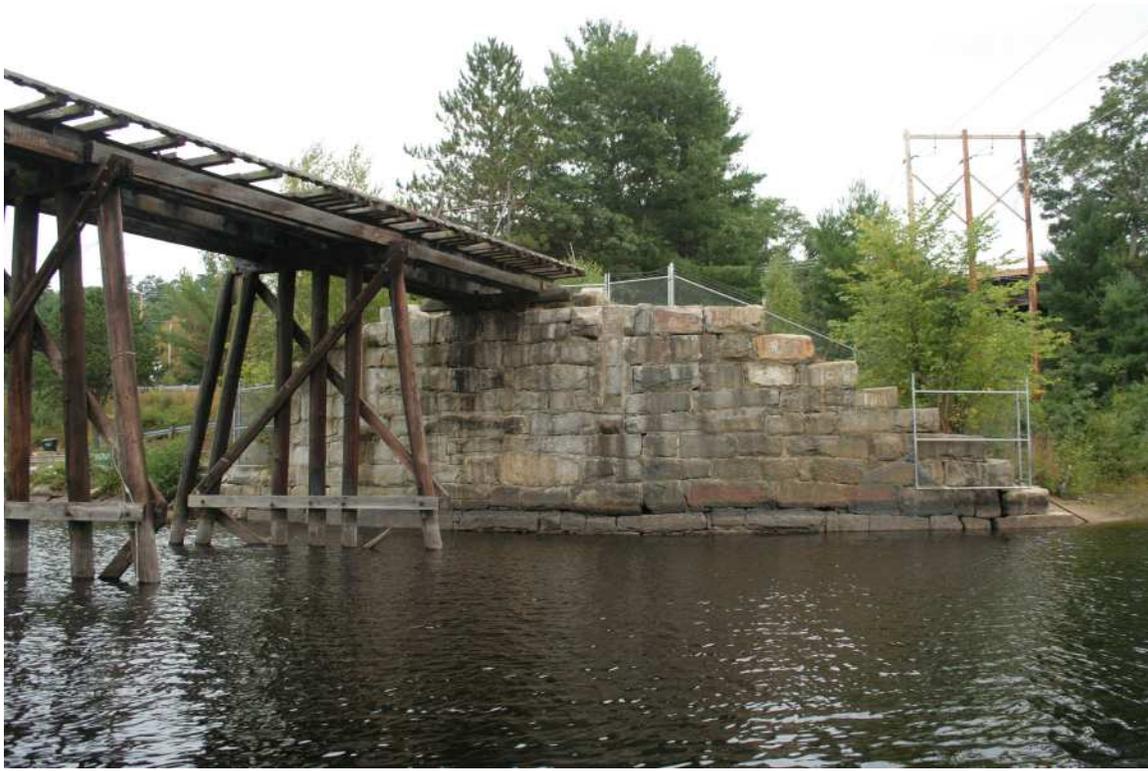
Photo # 6 description: South side of Manchester abutment.

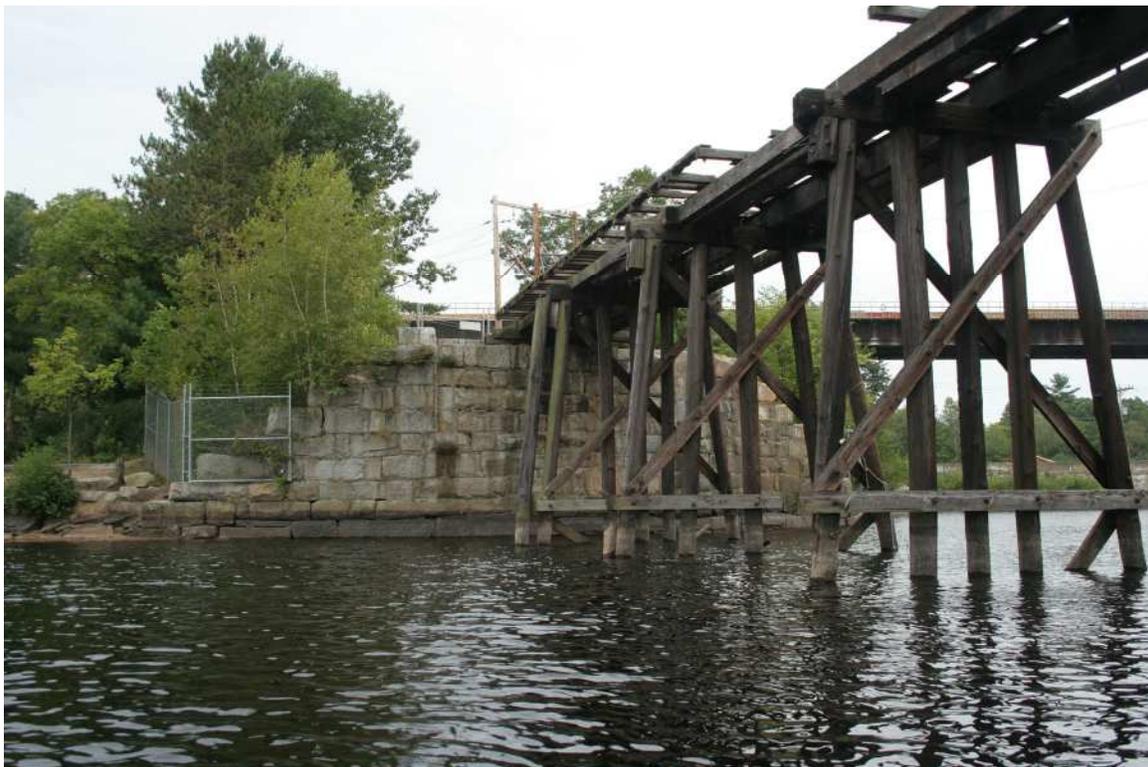
Photo # 7 description: Pile bents and north side of Manchester abutment.

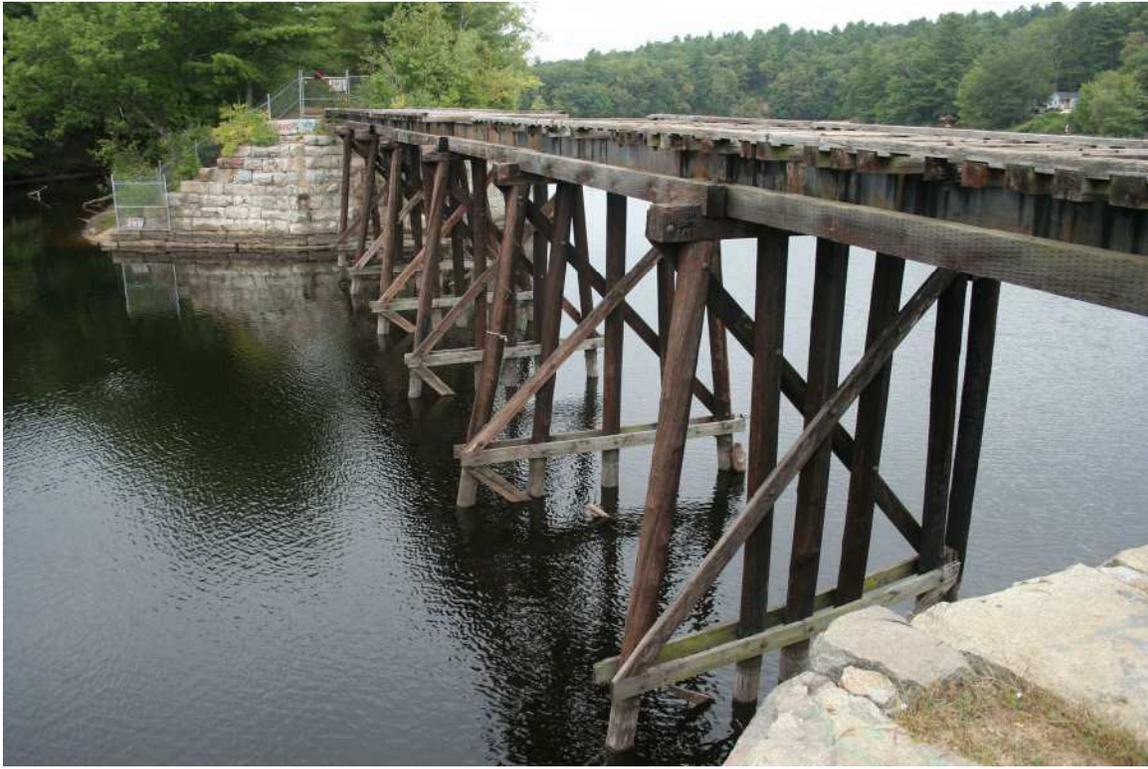
Photo # 8 description: Oblique view of pile bents .

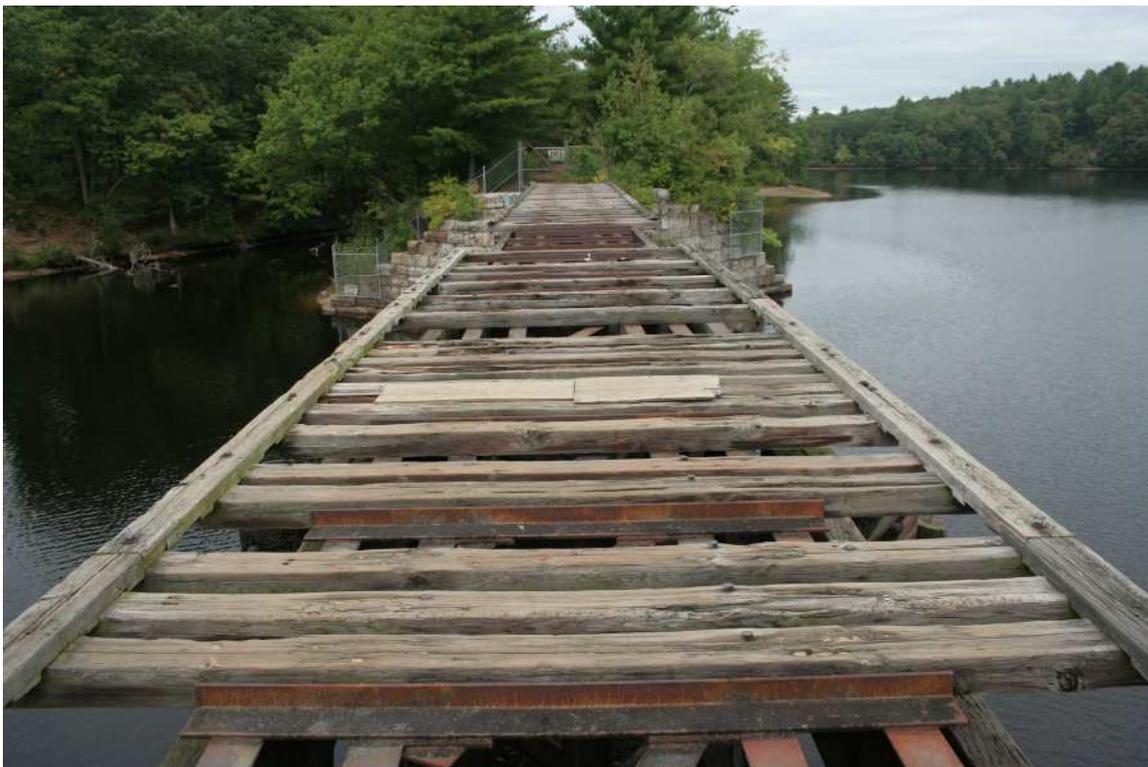
The four stringers are 20" American Standard Beams with 6-1/4" flanges weighing 65.4 pounds per foot. The stringer pairs are spaced with 12" wood blocking and tied together with four steel stringer clamps per span. The stringers are carried on timber pile caps measuring 12" x 14" x 14 feet long. The stringers are not end-butteted and joined with splice plates over the bents typical of highway spans, but instead are offset just enough to bypass one another and overhang the caps by about 8 inches. At some later time (not shown on the plans) the stringers were laterally braced with steel angles welded to the stringers, both diagonally and perpendicular (see Photo 9). The 6"x8" ties are spaced 14" apart but several were removed at intervals to allow the installation and welding of the later-added lateral bracing.

Photo # 9 description: Deck view: rotted or missing wood ties; steel angle welded to I-beam stringers.

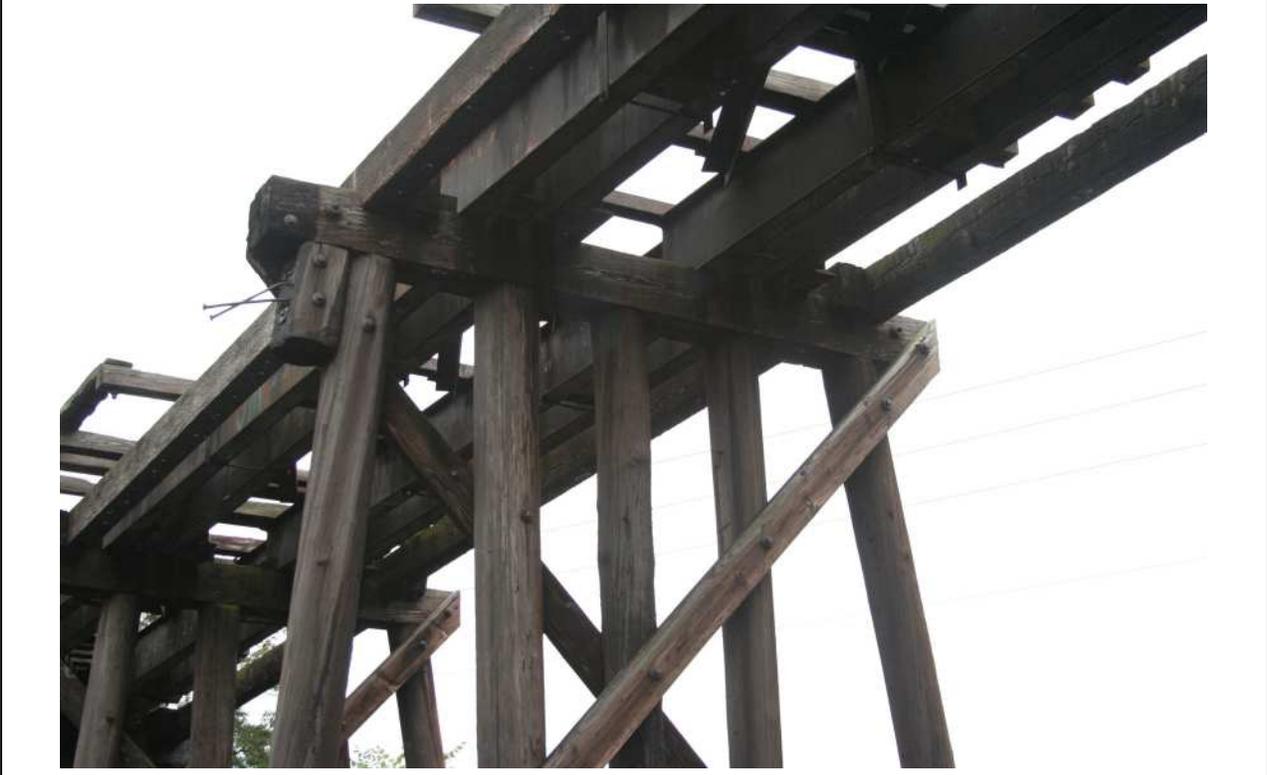
Photo # 10 description: Detail of pile bent, cap, bracing and steel I-beam stringers.

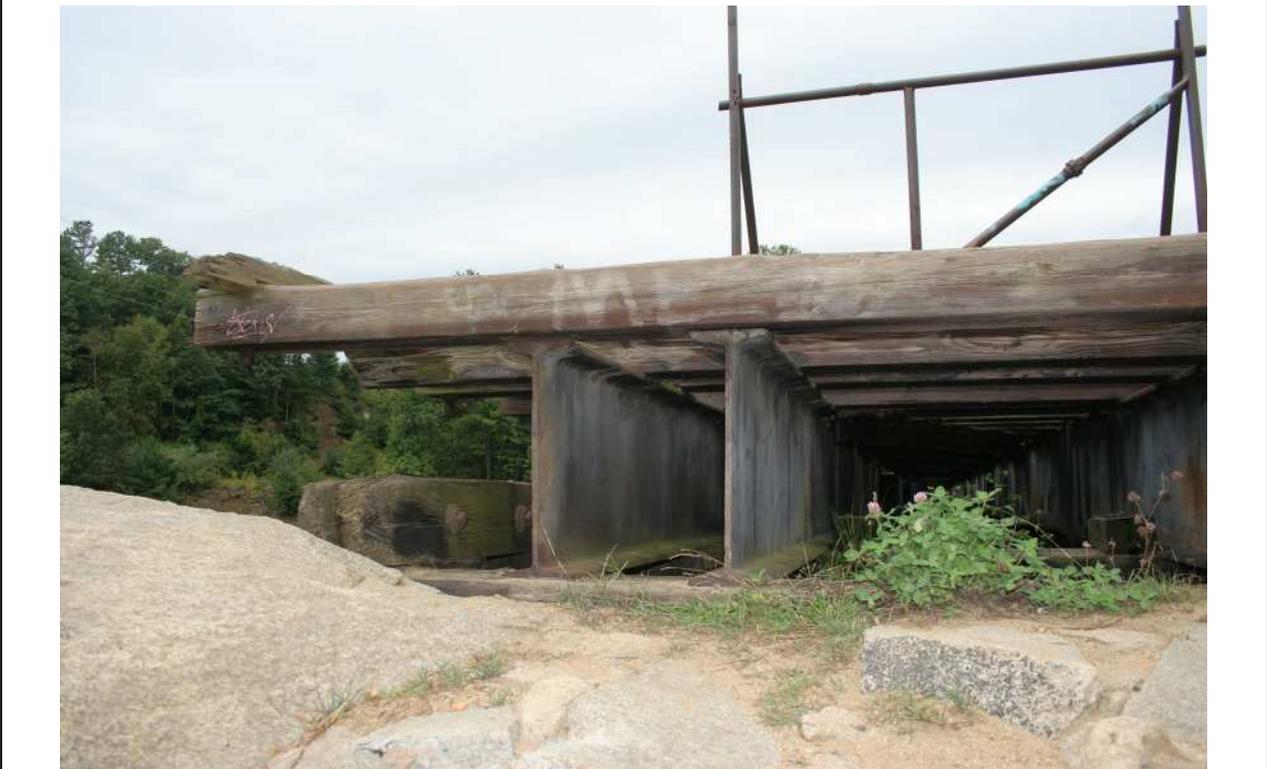
Photo # 11 description: Detail of double steel I-beam stringers supporting wood ties.
