# THE AMOSKEAG

Standards for Rehabilitation  
within the  
Amoskeag Corporation Housing Historic District  
Manchester, New Hampshire

CYNTHIA HOWARD A.I.A. & ASSOCIATES  
ARCHITECTS & PRESERVATION PLANNERS  
Cambridge, Massachusetts

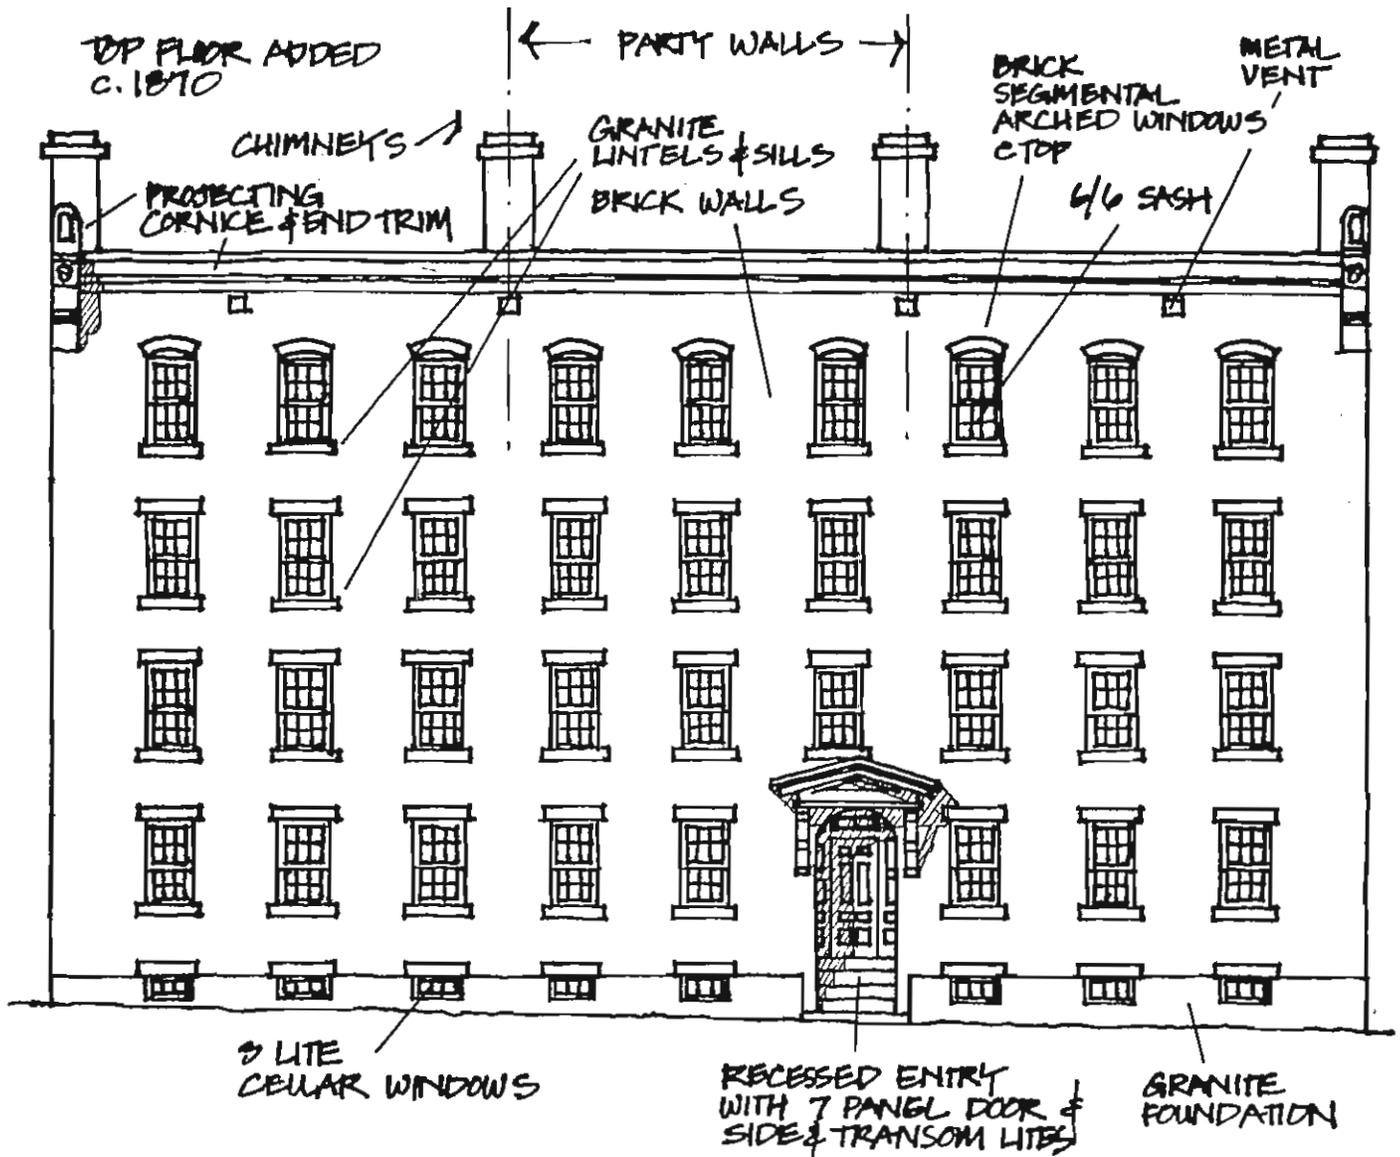
### STARK MILL TENEMENTS FRONT ELEVATION

The buildings were constructed c.1838; the fourth floors with segmental-arched windows were added c. 1870. Entries were blocked down slightly in size, and new hoods with wooden brackets were added by the Amoskeag over a number of decades; a variety of 'Amoskeag style' doors can be found on these buildings.

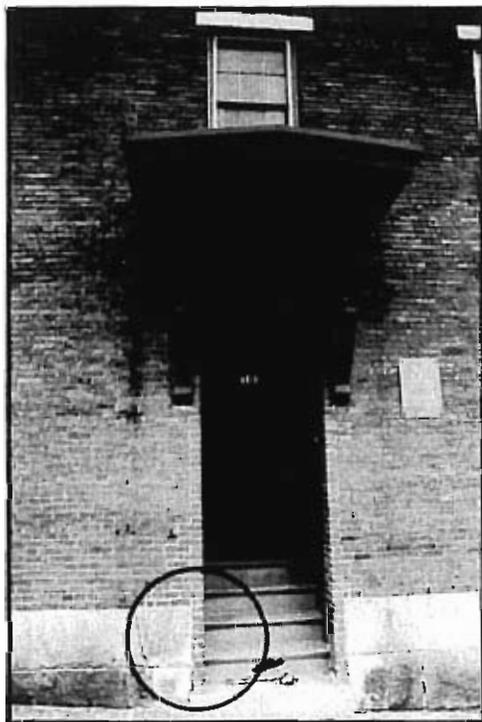
Entry, Mechanic Street tenement. This is most likely a later (Amoskeag) alteration. Note how the entry has been bricked narrower than the original granite opening.

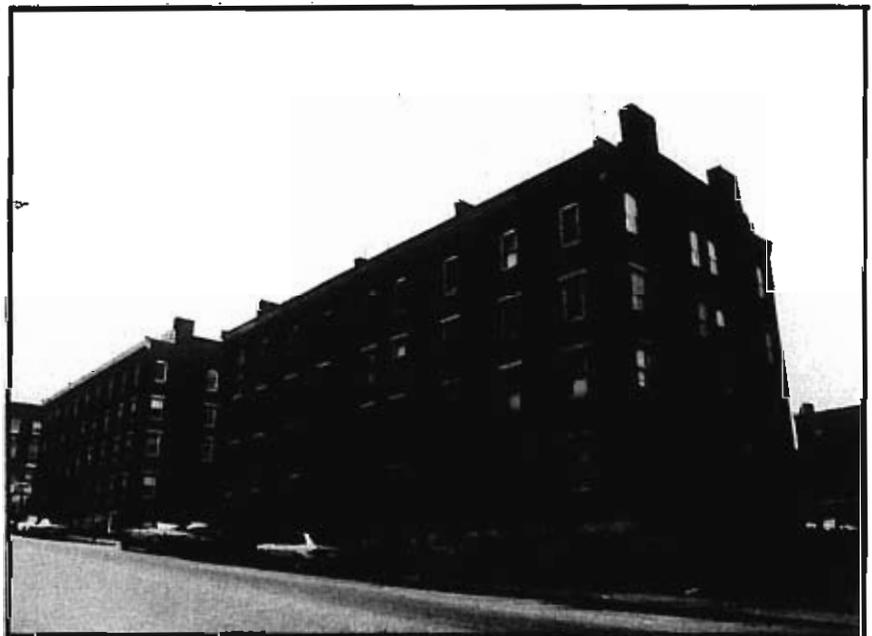
As with all Amoskeag structures, the regular pattern of windows are a principal design feature. Openings should not be altered.

Original paneled doors, transom and side lites, granite steps, and entry hoods, should always be retained.

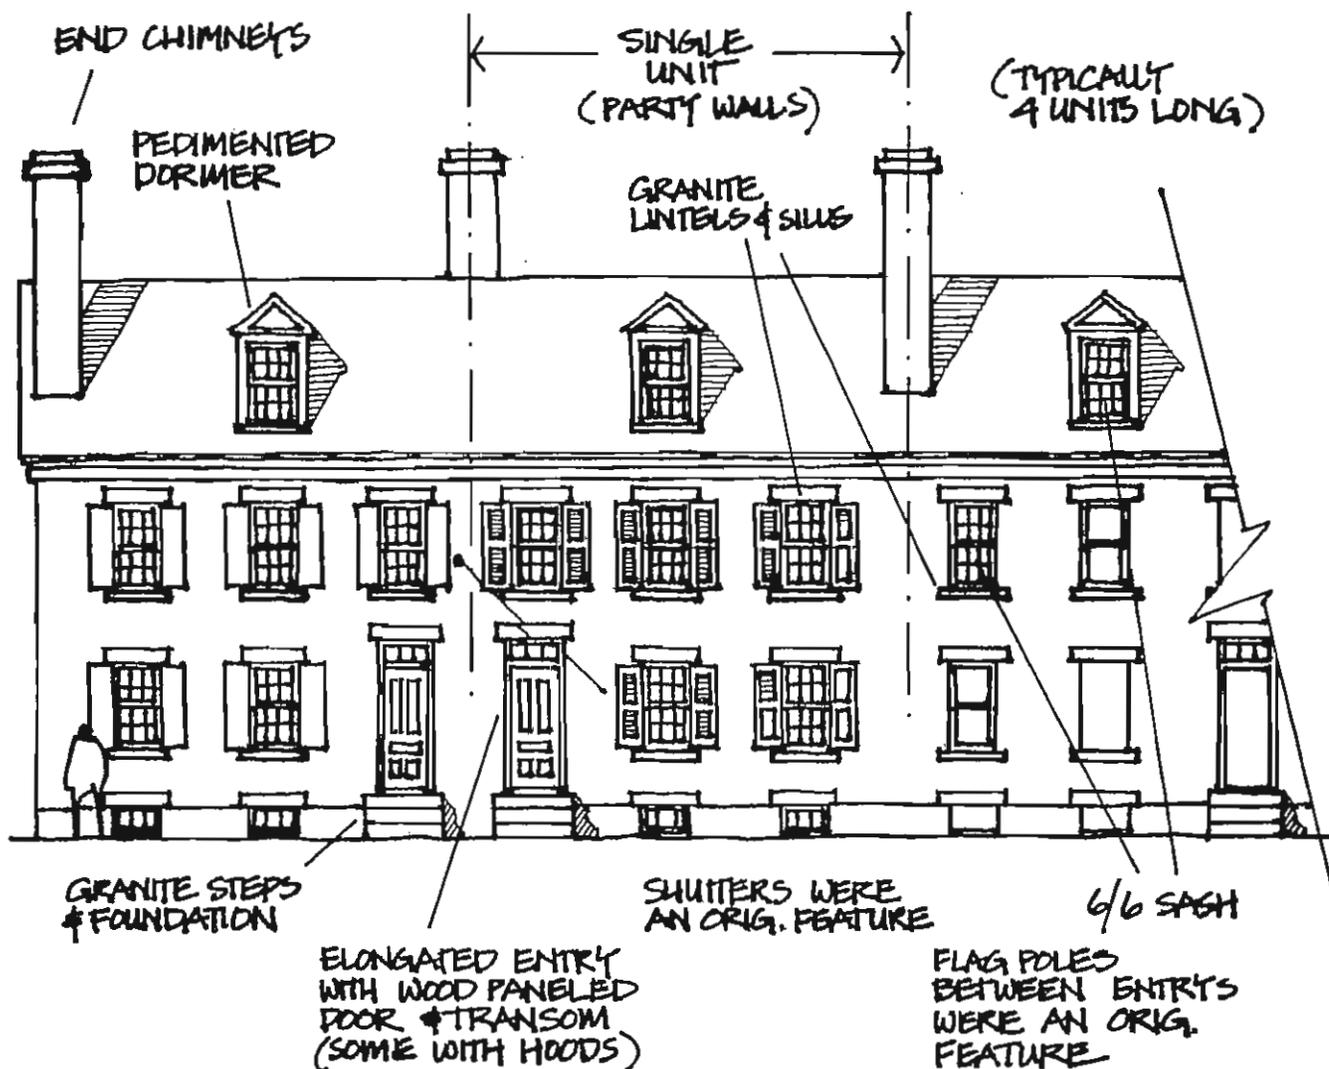
OVERSEERS HOUSES  
FRONT ELEVATION

On the overseers houses the traditional Amoskeag pedimented entry hood was extended in width to cover two entrances. Some brackets were originally wood, others iron.

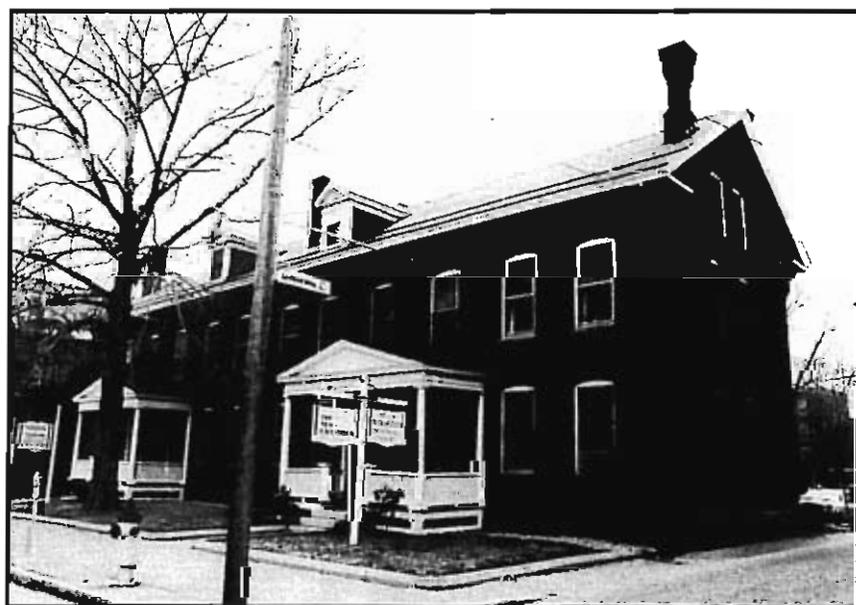
A one-of-a-kind in the District, this late 19th Century building on Market Street is similar to the overseers buildings in plan and massing. Its brick detailing at the cornice and on the chimneys is more decorative and it has segmental arch, rather than granite lintel, windows.

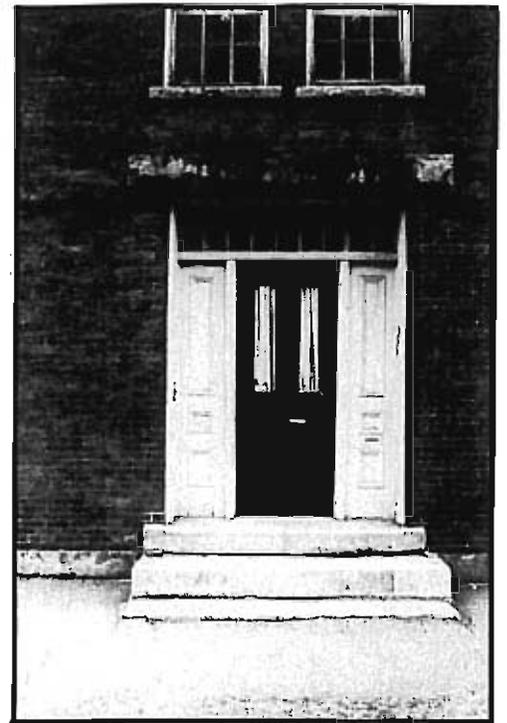
First Floor Plan

Traditional entrance at narrow end of tenement buildings. Many entries in the District have paired doors. (See Section III for additional examples of original Amoskeag entries and doors.)

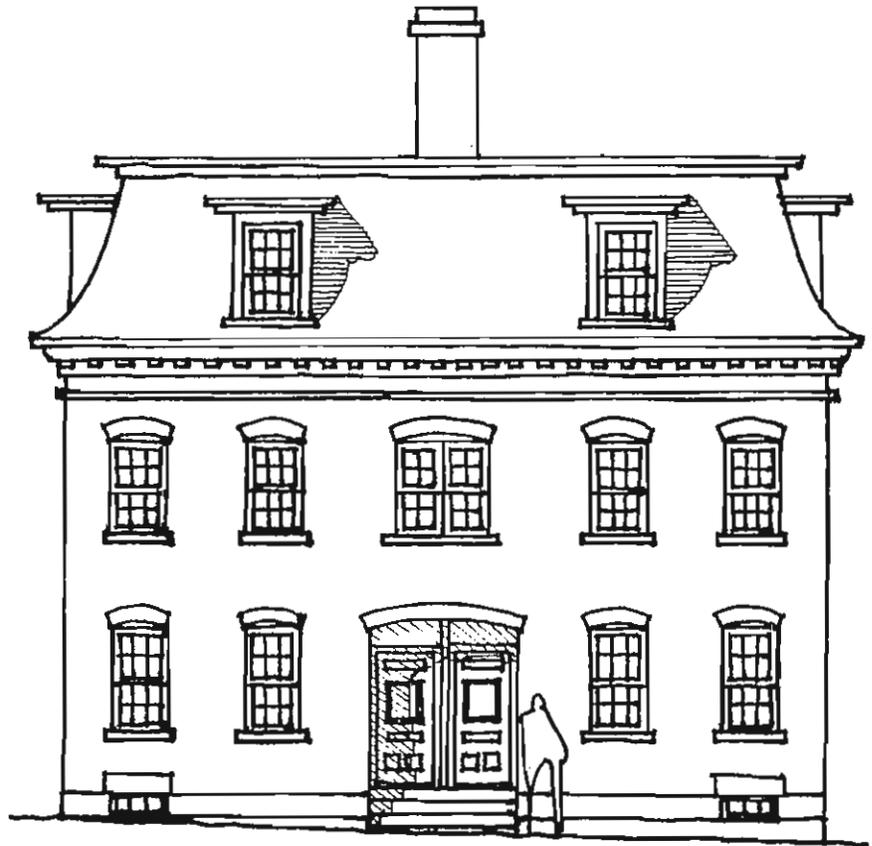
**MANSARD TENEMENTS  
END ELEVATION**

Tenements along the south side of West Merrimack Street were the last workers' houses built in the District.

While by 1866 6/6 sash had largely been replaced by 2/2 (or 6/1, 2/1) sash in contemporary construction, the Amoskeag's design conservatism can be detected in their continued use of the 6/6 window sash used on earlier tenements.

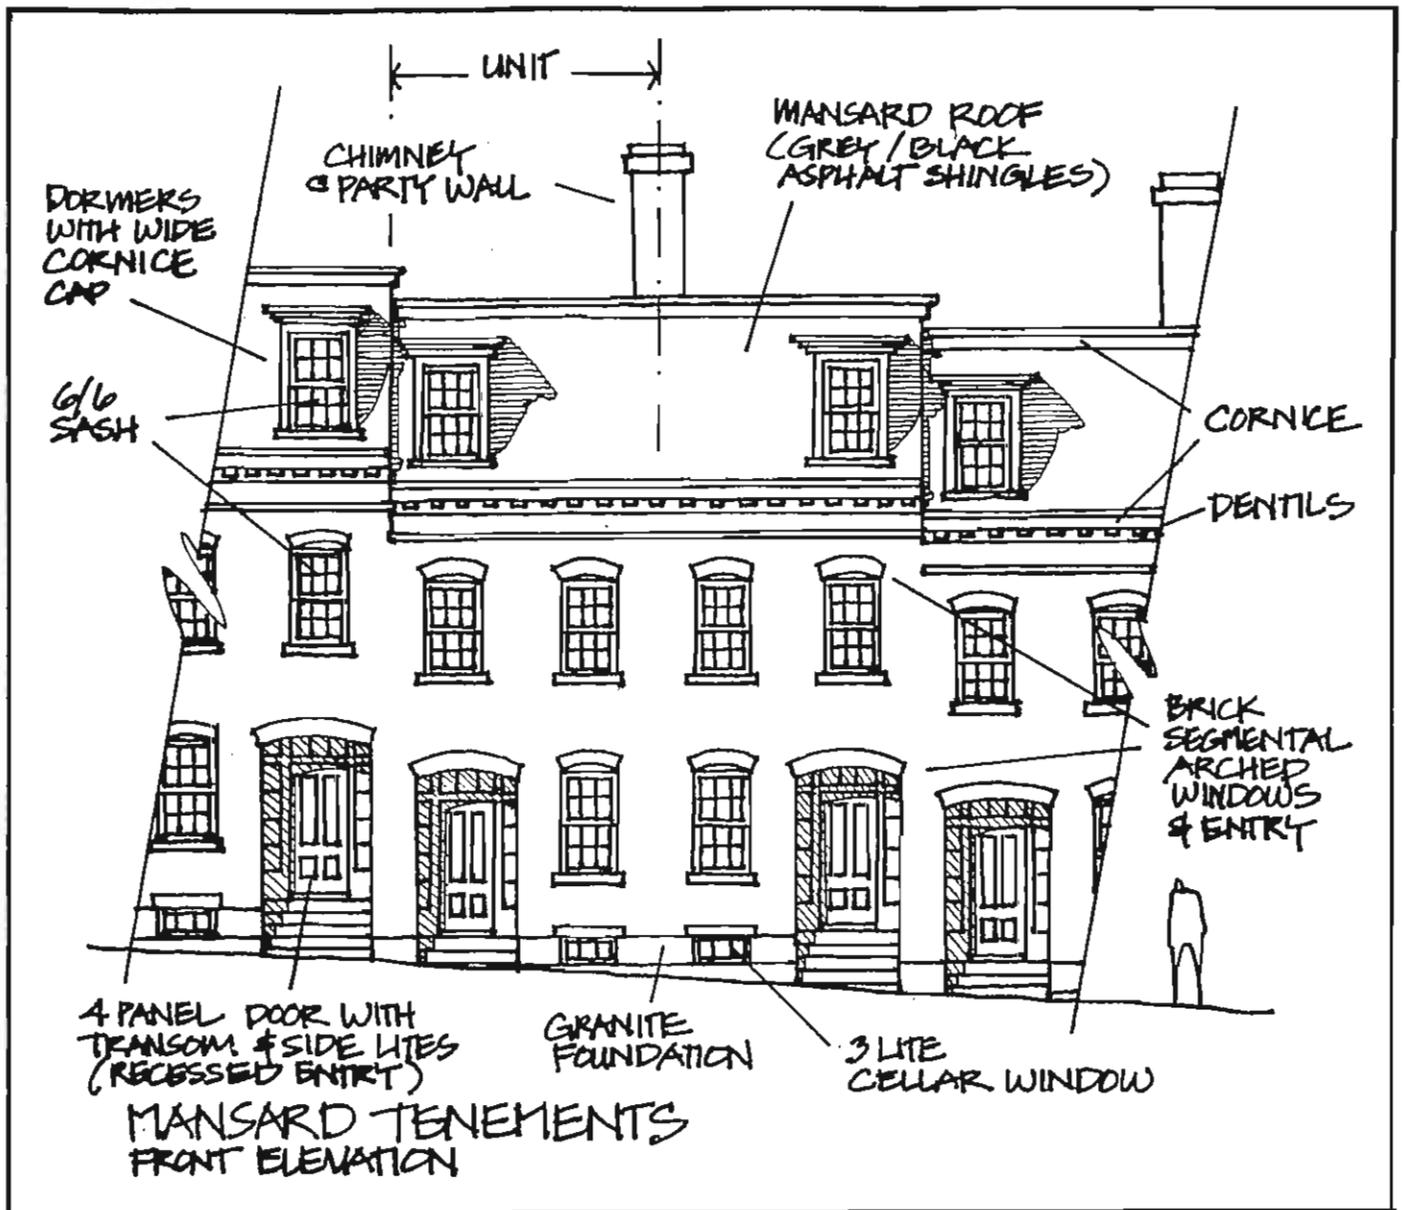
This double-pitched ('mansard') roof, with its 'bell-cast' profile, gives the buildings a distinctive 'top' (as do the gable roofs on other tenements.)

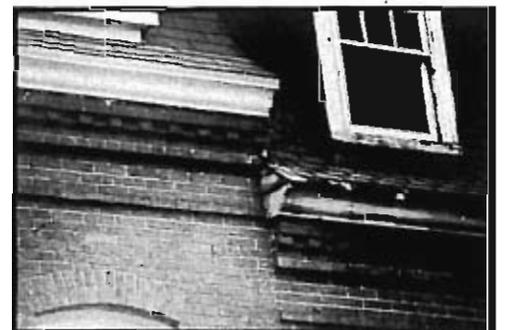
Brick detailing and wood cornice at roof edge.

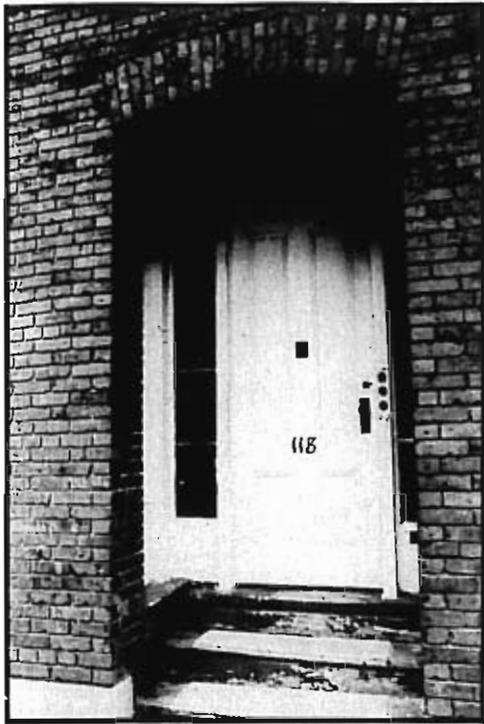
The entry of 118 West Merrimack Street with its original 1866 door, transom, and side lites.

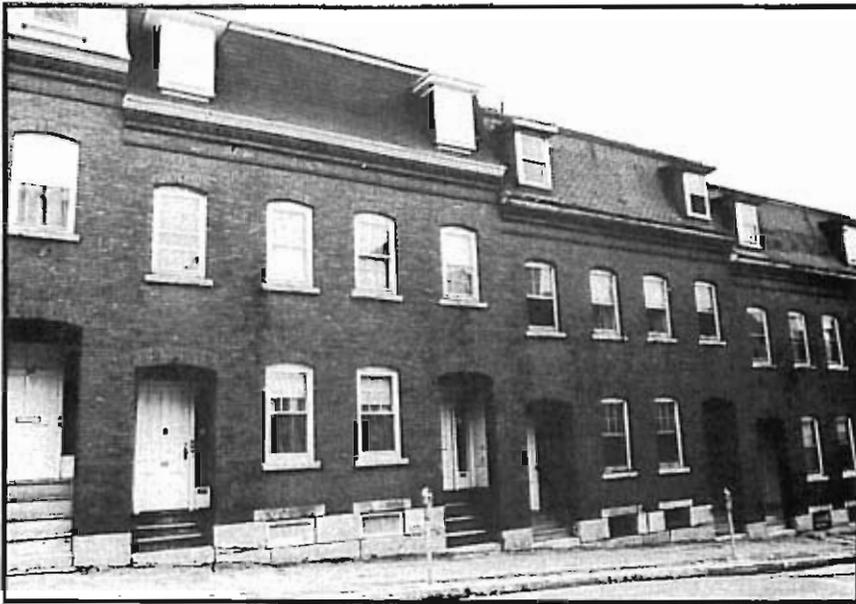
Mansard tenements stepping down the hill along West Herrimack Street.

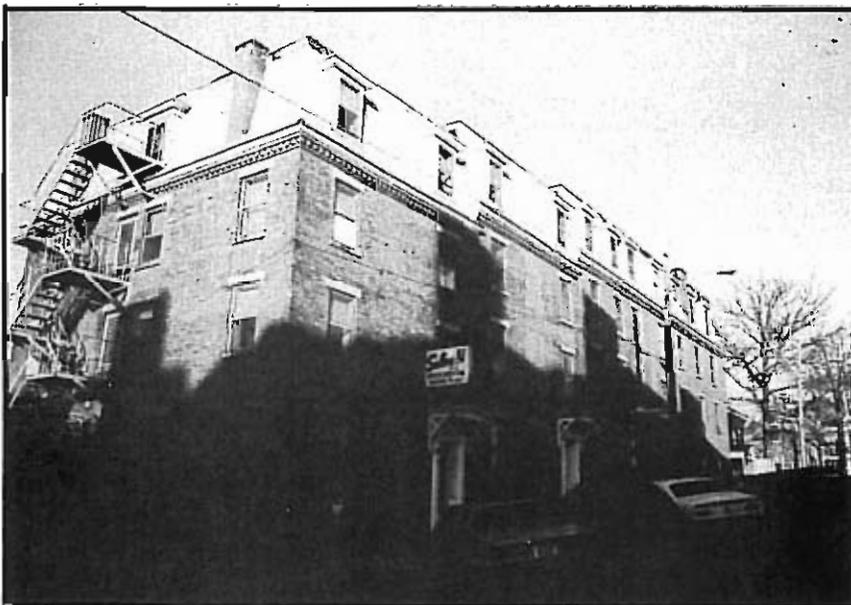
This Market Street building is the only other building with a mansard roof in the District. Originally a tenement, the structure was enlarged and converted to a girls boarding house in 1872.

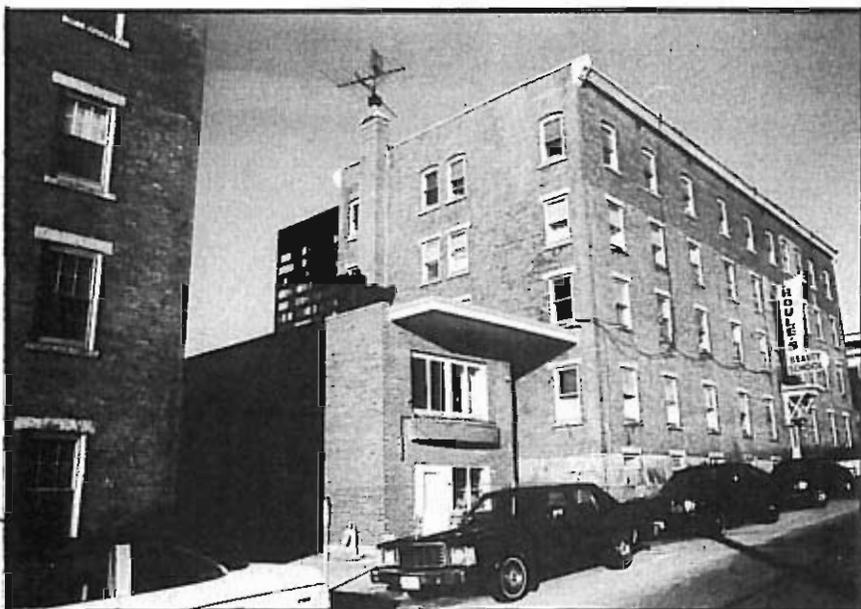
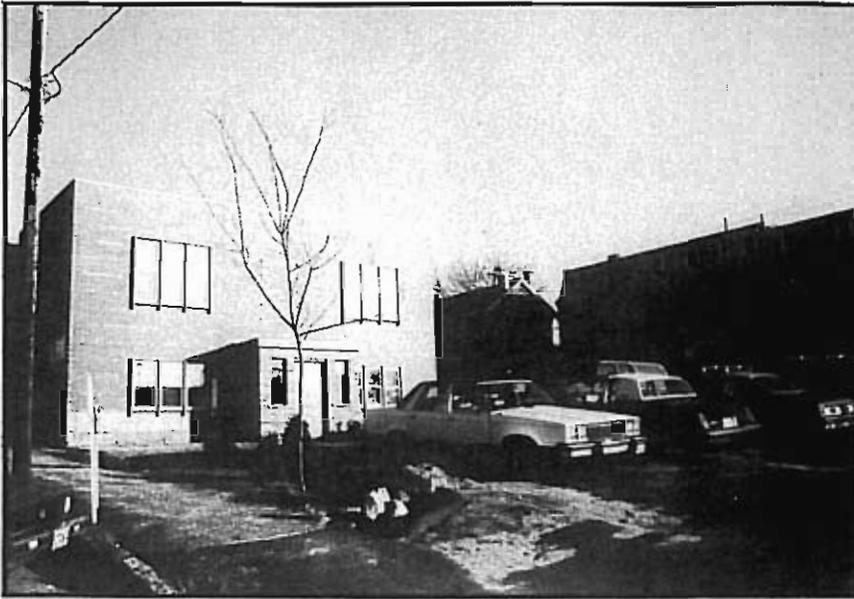
Photos opposite page: (top) A new one-story building of yellow brick insensitively jammed into an Amoskeag tenement. (bottom) The windows and strange roof on this small building create an appearance which is alien to the District.

New structure in the District. Amoskeag buildings have a distinct 'top', and always orient their major entry towards the street or thru-alley. With minor changes this building could have been designed to be more sympathetic to its historic neighbors.

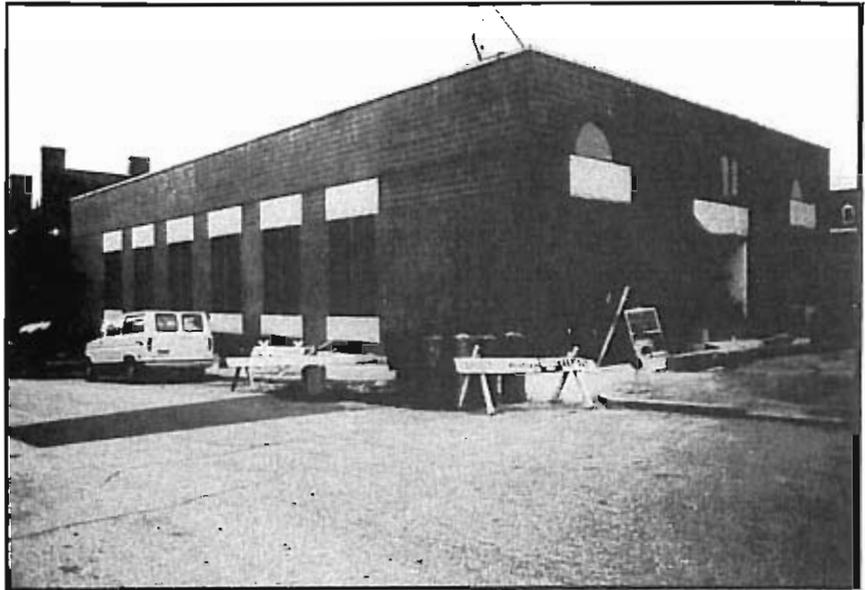
The former American Legion Sweeney Post. This is a handsome renovation. The use of brick and granite, materials characteristic to the area, and the creation of a visual 'top' by a change in brick detailing, are sensitive features.

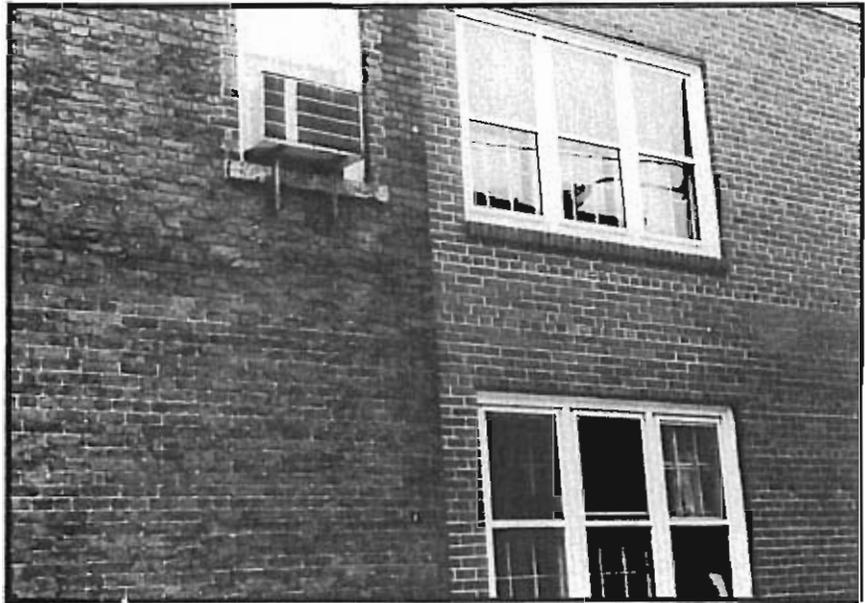
Detail of a brick addition to an Amoskeag building. Note that the brick pattern has been matched, but that the color of the brick and mortar does not match. Additions to buildings are probably best constructed of materials which make it obvious the addition is new.

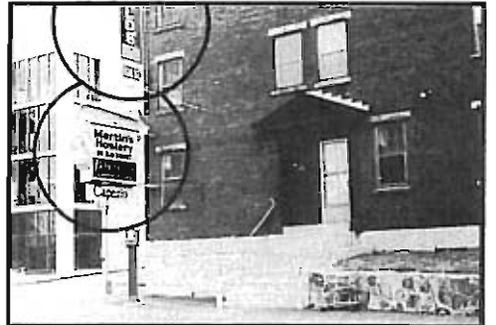
It might be appropriate to limit allowable sign size per commercial tenant.

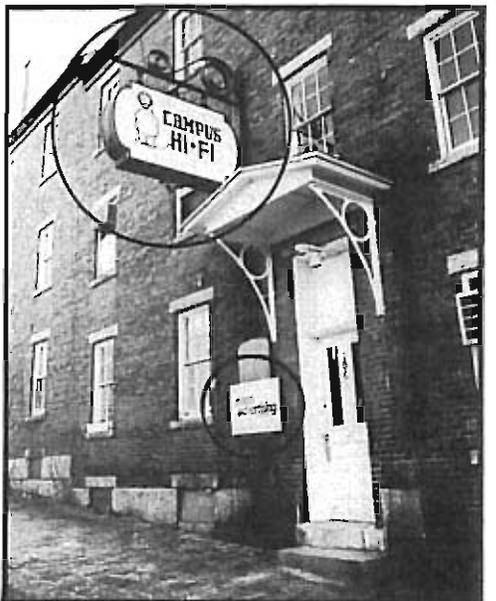
An ordinance should specify allowable locations for signs. (Flat signs on the wall next to the entry, or free-standing pole-mounted hanging signs. Small wall-mounted projecting wooden signs might also be acceptable).

The ordinance should specify the type of signs allowed. Self-illuminated signs should be prohibited. Signs which have nothing to do with the District, such as signs identifying businesses on Elm Street or other off-premises signs, should not be allowed.

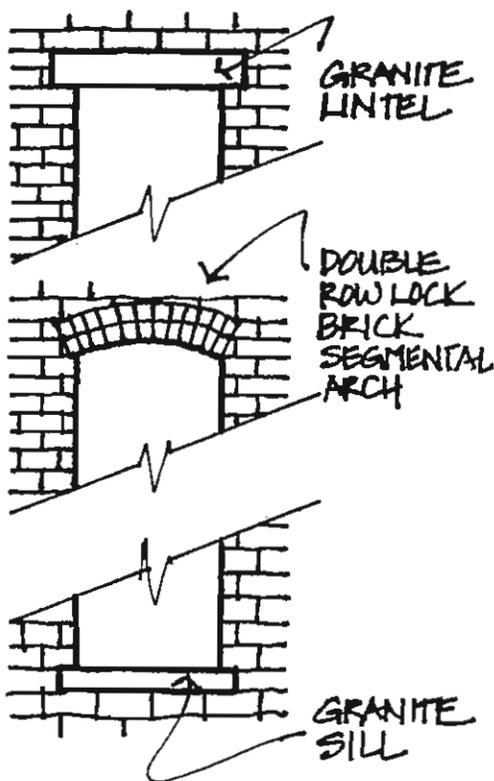
Granite and brick arches and sills found on Amoskeag buildings. Both handsome and durable, these features should always be retained.

Brick masonry is the principal structural system used throughout the District. Steps, foundations, lintels and window sills are granite.

Granite is by far the hardest of building stones, and is extremely resistant to wear. Although it is an expensive stone to cut and finish, the cost can be justified on the basis of performance. Where, for example, concrete steps will deteriorate quickly, granite steps will last as long as the mortar between blocks is maintained.

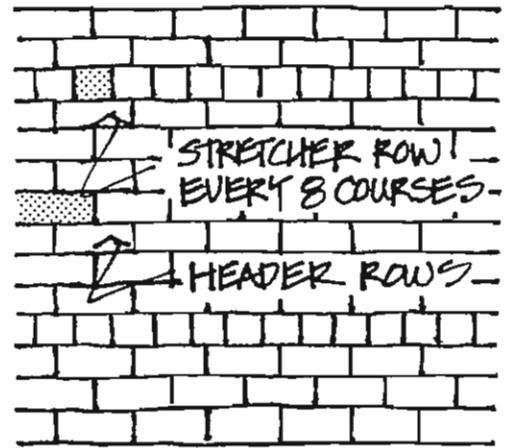
## AMERICAN COMMON BOND

The brick pattern found on Amoskeag buildings : 'American Bond'.

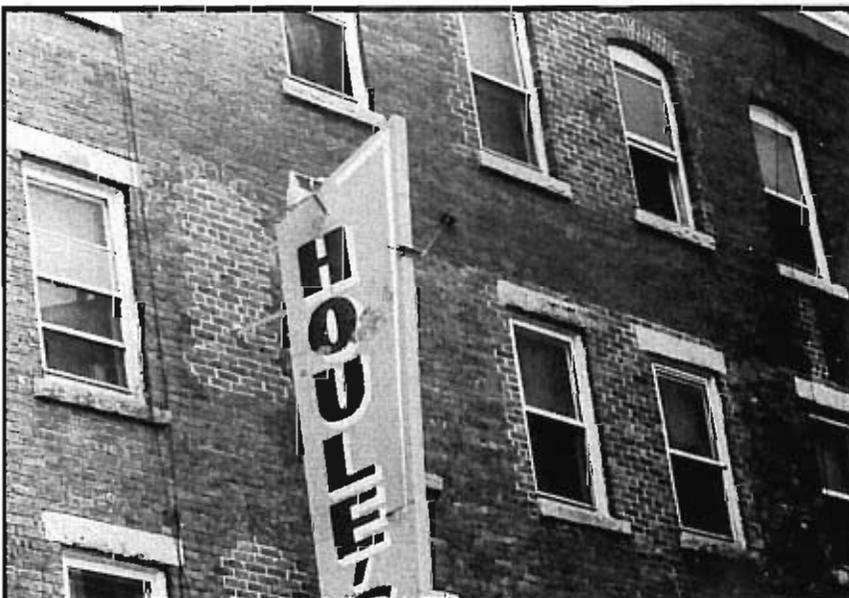
Looking carefully at this wall, one can detect openings which have been bricked in. New mortar was improperly matched in color to the old mortar.

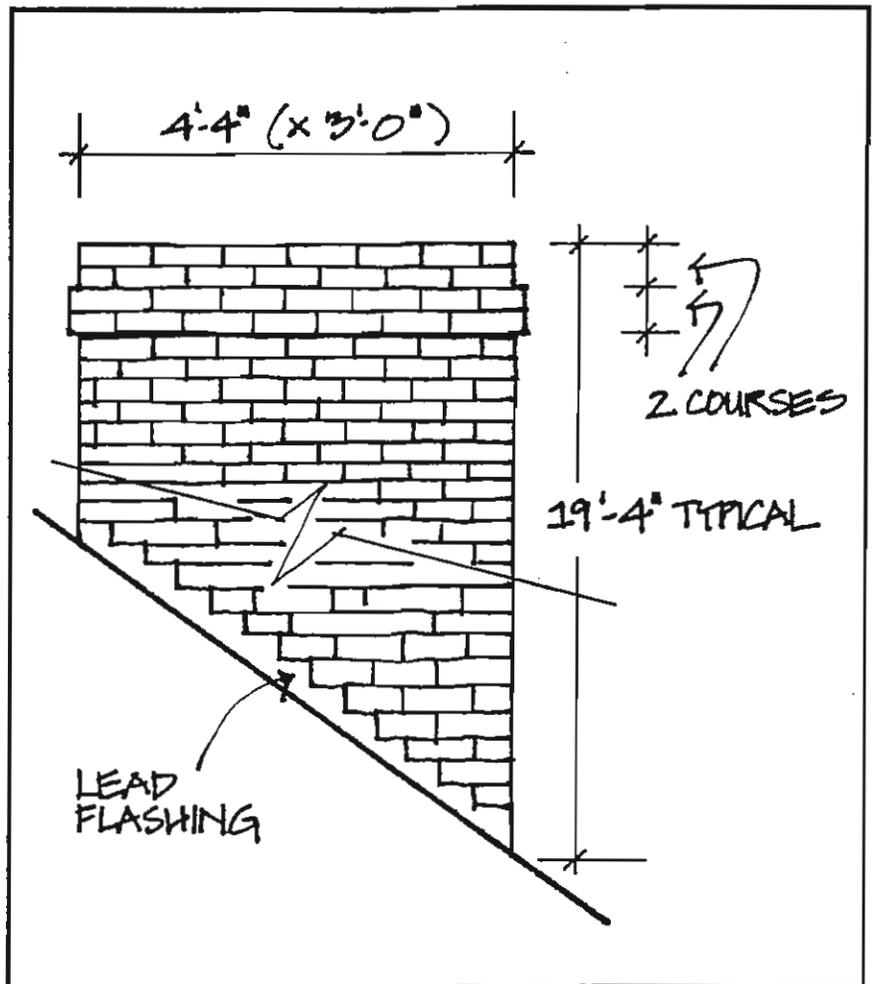
The similar shape and height of chimneys are an important feature of the District. Top projection, shape and height should not be altered.

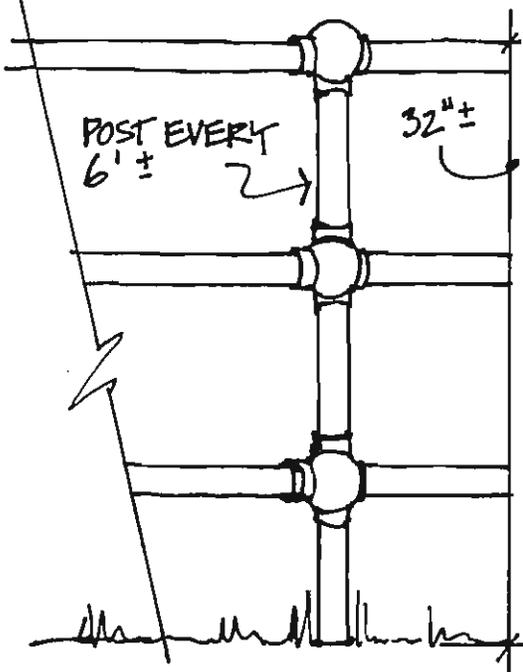
## AMOSKEAG IRON FENCE:

The traditional Amoskeag Iron fence found in the District, and in slightly different form, originally within the Millyards.

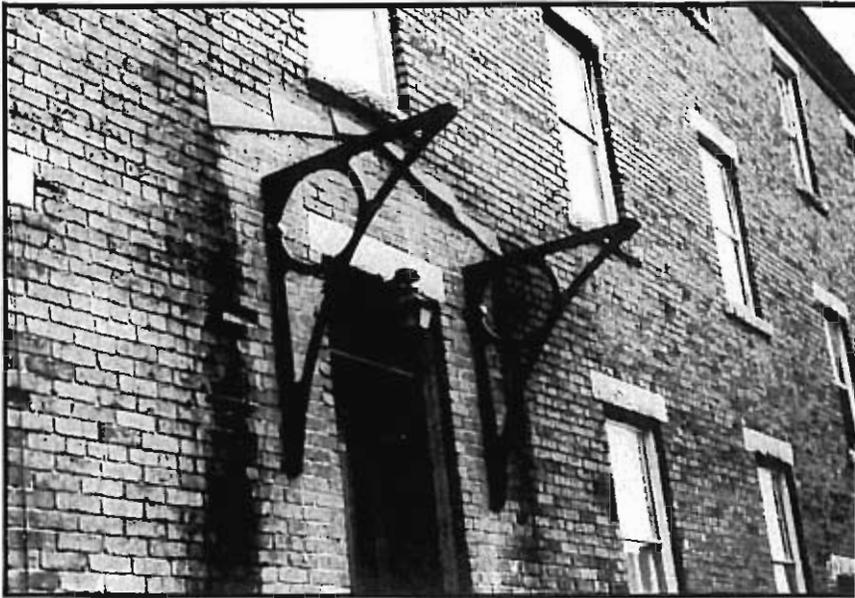
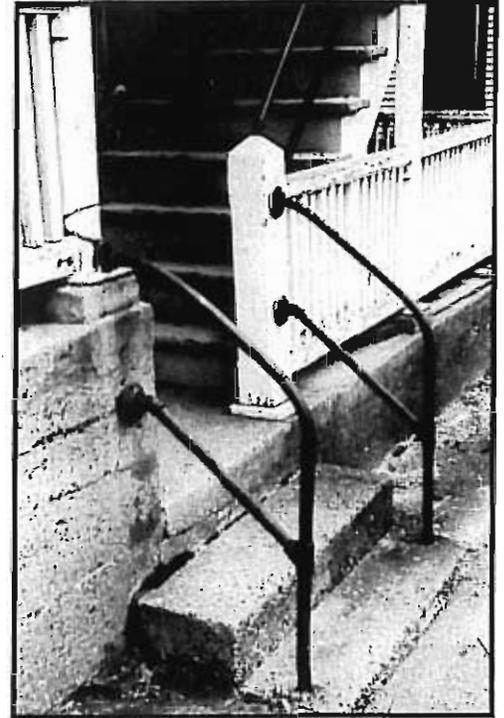
A common cause of deterioration of iron brackets, stair rails and fences is the rusting of the iron clips or bolts with which the pieces are fastened to wood or masonry. These fasteners should be checked and replaced if necessary with stainless steel fasteners (painted black for appearance). These repairs are best performed by a reputable ornamental iron installer.

Brackets (left photo) being replaced on a building undergoing renovation. The photo above is of a traditional iron stair rail found on rear porches of tenements along Pleasant Street.

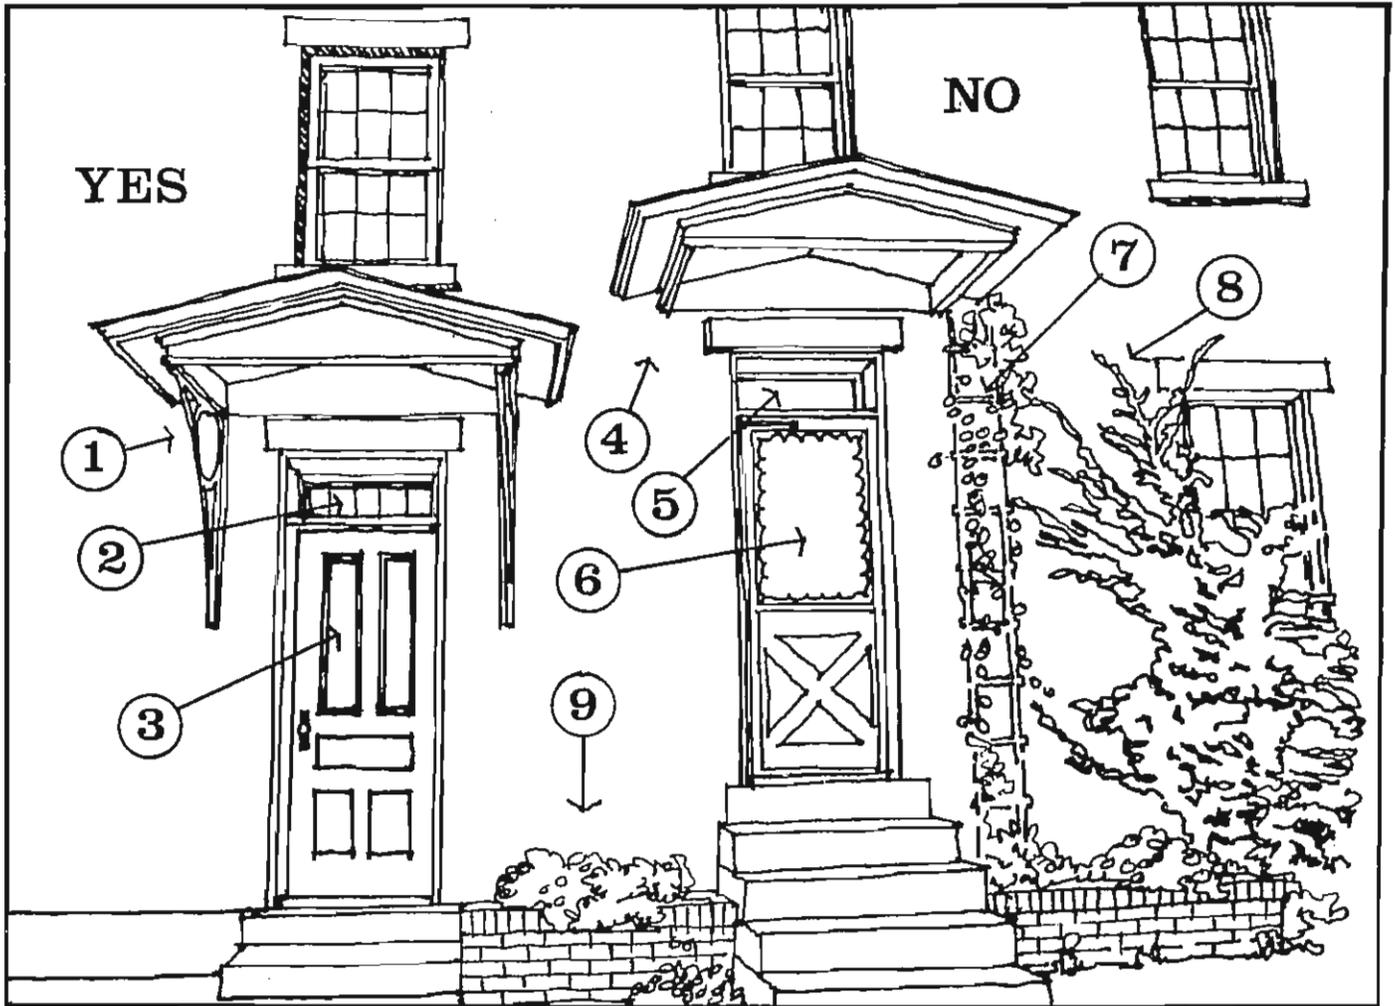
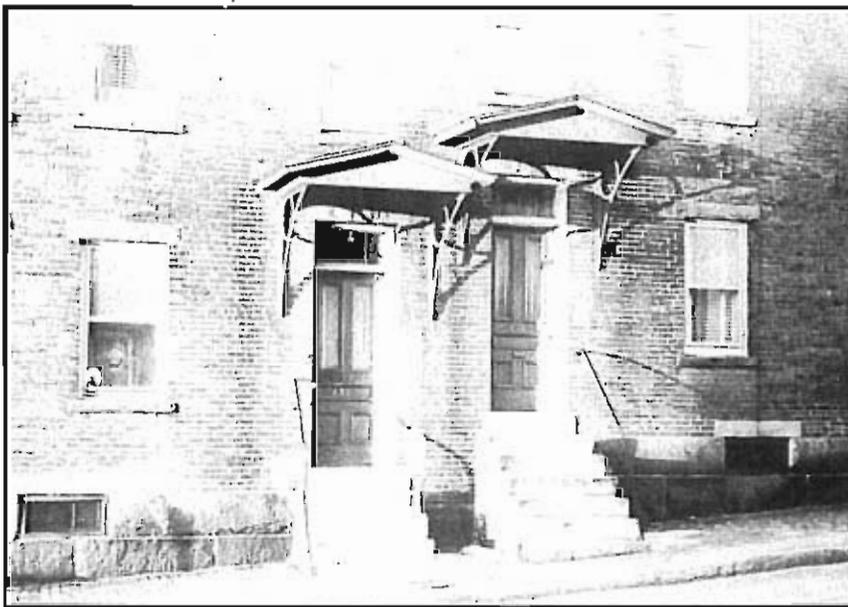
1. Original Amoskeag bracket
2. Five-lite transom
3. Five-paneled door
4. Bracket removed
5. Transom altered
6. Inappropriate 'Colonial' storm door
7. Trellis at entrance is visually too 'busy'.
8. Ivy overwhelms entry, and can damage brick and mortar.
9. Brick planters mar the original design simplicity of the building and entrance, and should be avoided.

The drawing on page 55 illustrates other additions to the entrance which should be avoided. Trellises or wall ivy visually overwhelm the design of the entry. (And can seriously damage mortar and brick).

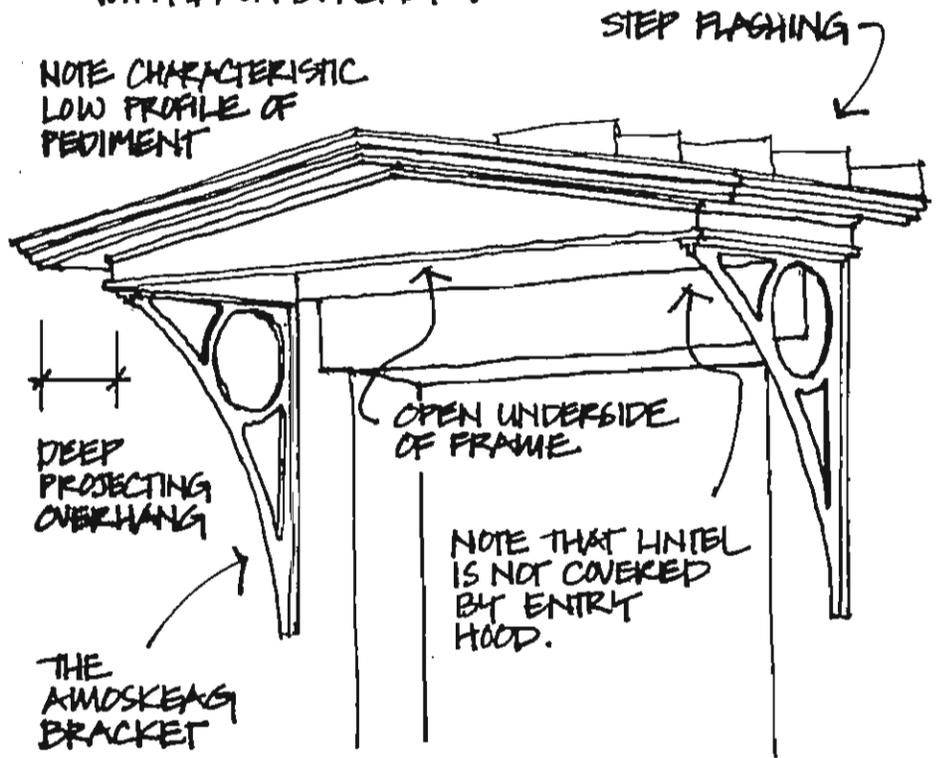
THE AMOSKEAG ENTRY HOOD  
WITH IRON BRACKET:

Design details of the traditional Amoskeag pedimented entry hood.

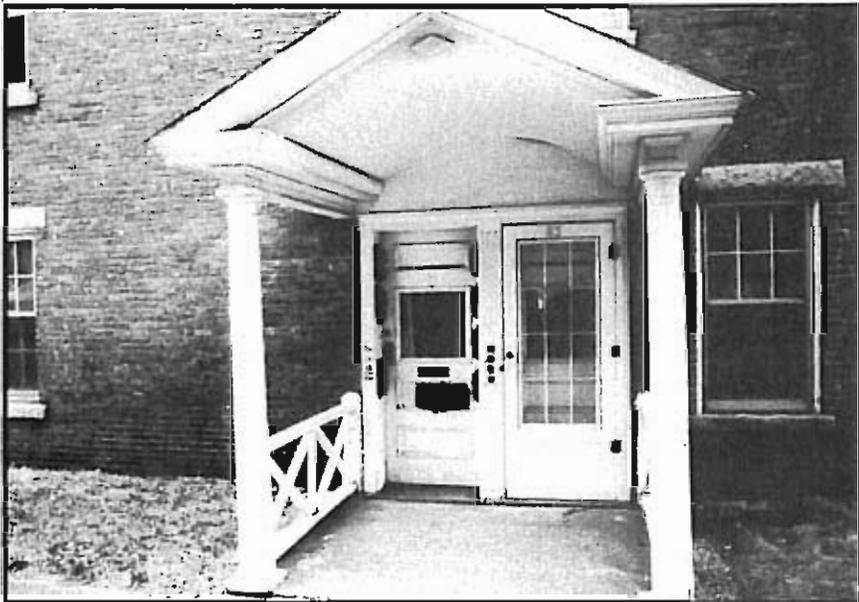
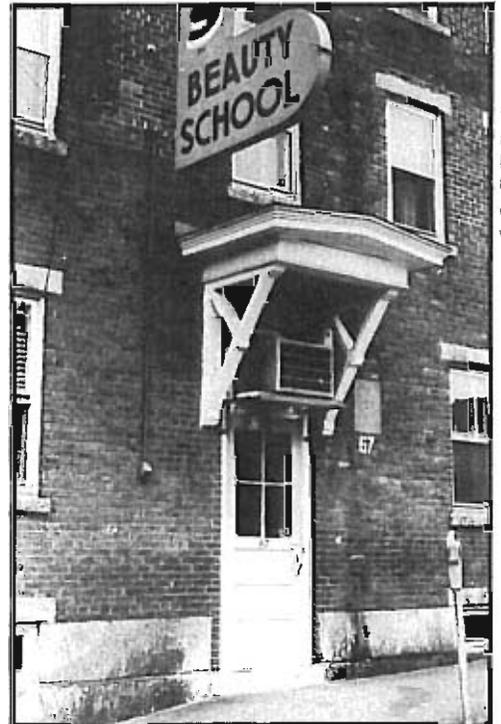
Photos illustrating the variety of entry types found in the District. The photo below illustrates what not to do to an entry: door blocked down, A/C unit exposed, and oversized sign and electrical hook-up.

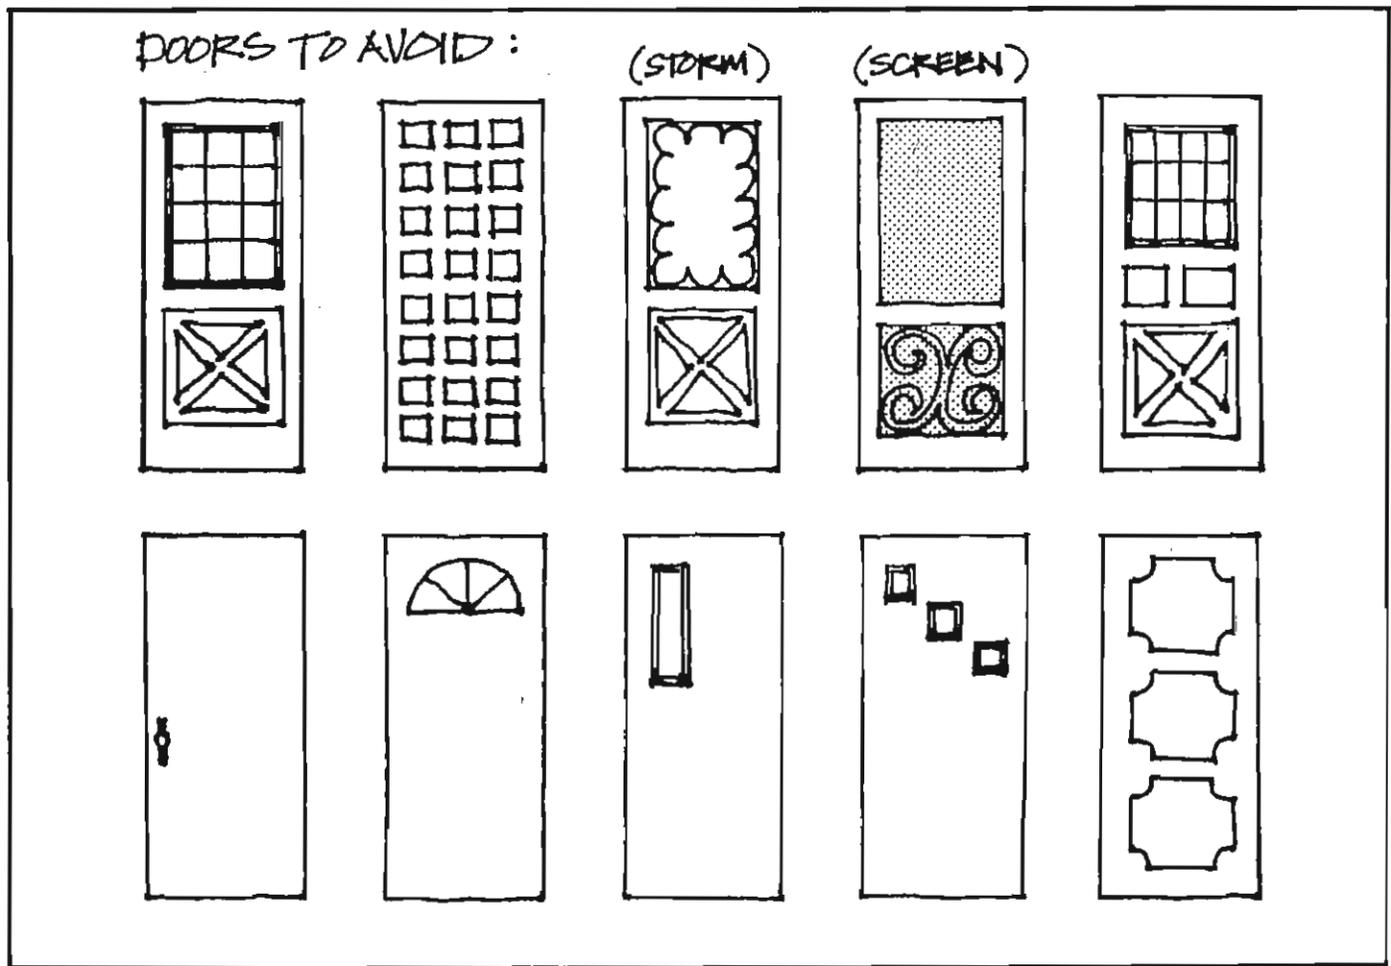
Doors which should never be used on District buildings.
