# THE AMOSKEAG

Standards for Rehabilitation  
within the  
Amoskeag Corporation Housing Historic District  
Manchester, New Hampshire

CYNTHIA HOWARD A.I.A. & ASSOCIATES  
ARCHITECTS & PRESERVATION PLANNERS  
Cambridge, Massachusetts

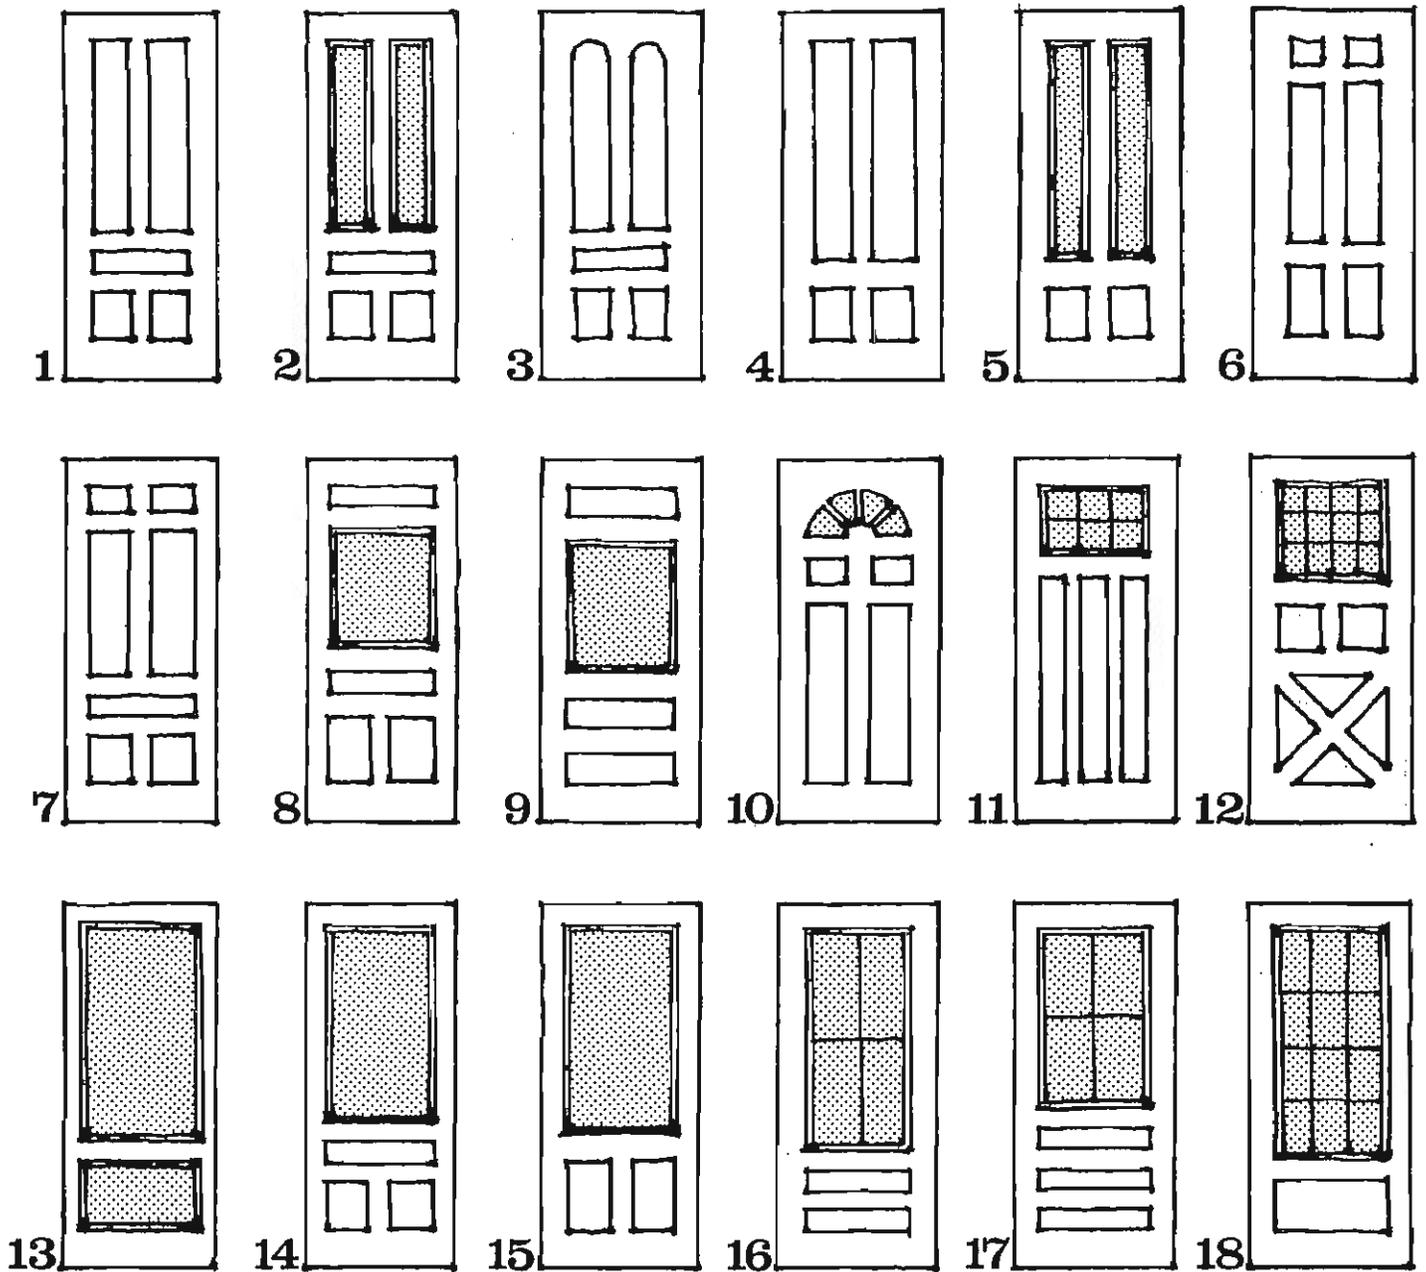
The Amoskeag doors illustrated can be found on the following buildings:

- 1,2 on tenements and overseers houses ; this is the most common Amoskeag door.
- 3 historically found on tenements as a variation of door #2, though none of these doors remain.
- 4 on mansard tenements and throughout the District on rear ells.
- 5 on rear ells
- 6 on some mansard tenements. This is probably a later alteration.
- 7 on Stark Mill tenements at Mechanic and Canal Streets; a later alteration.
- 8 on the end entrance of the tenement on the north side of Middle and Canal Streets.
- 9 on the tenement on the north side of Middle Street, and on some Stark Mill tenements.
- 10 on the overseers block at the north side of Middle Street.
- 11 on the overseers block on the north side of West Merrimack Street.

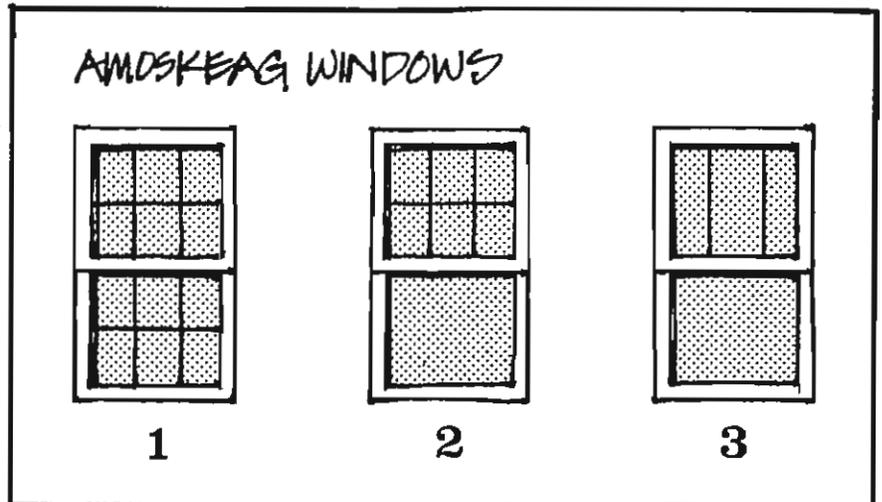
Six-over-six (6/6) double-hung window sash is the most common type of window in the Amoskeag Corporation Housing Historic District. It is the preferred window for replacement unless historic research indicates otherwise. Do not mix window styles on a given facade.

Other windows found in the District are:

- 2 a 6/1 window associated with the Queen Anne style of architecture popular c. 1875-1890. This window is found on overseers blocks facing east on the north side of Middle and West Merrimack Streets.

- 3 found on overseers houses on the south side West Merrimack Street. This 3/1 window type is rare and examples in the Amoskeag should be protected.
- 4 occasionally seen on the backs of tenements, this 2/1 window was probably installed as replacement for original sash in renovations c.1900. It is an odd window in an otherwise 6/6-windowed facade and should not be used today. (Exception: the rare instance it is evident on the entire facade.)

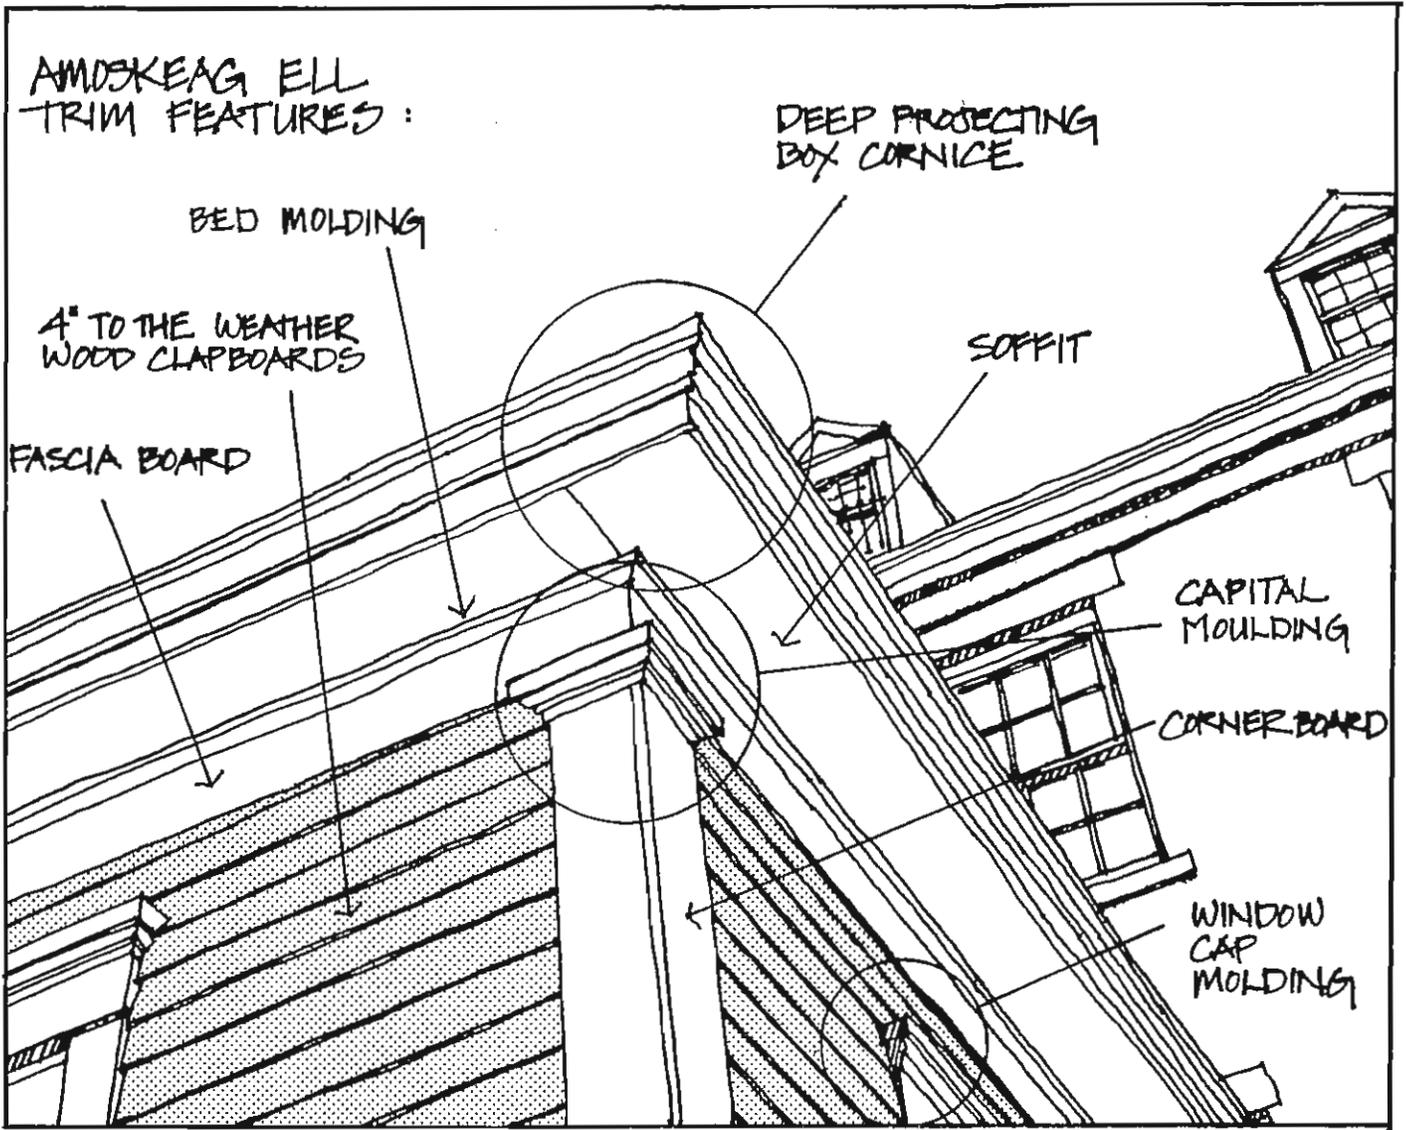
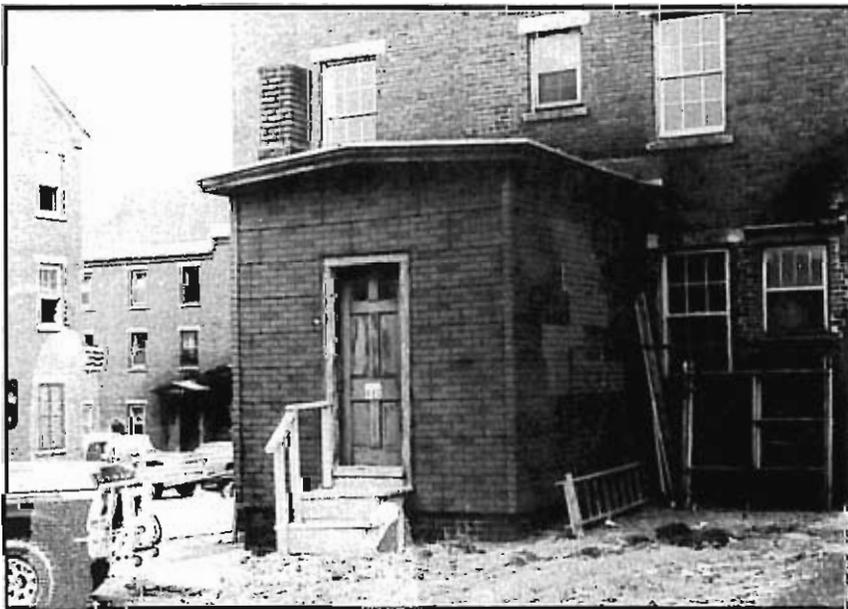
Trim details found on wood-frame Amoskeag ells. These elements should be retained in renovation. Photos show a well-maintained ell (opposite page), and a poorly-maintained ell (left).

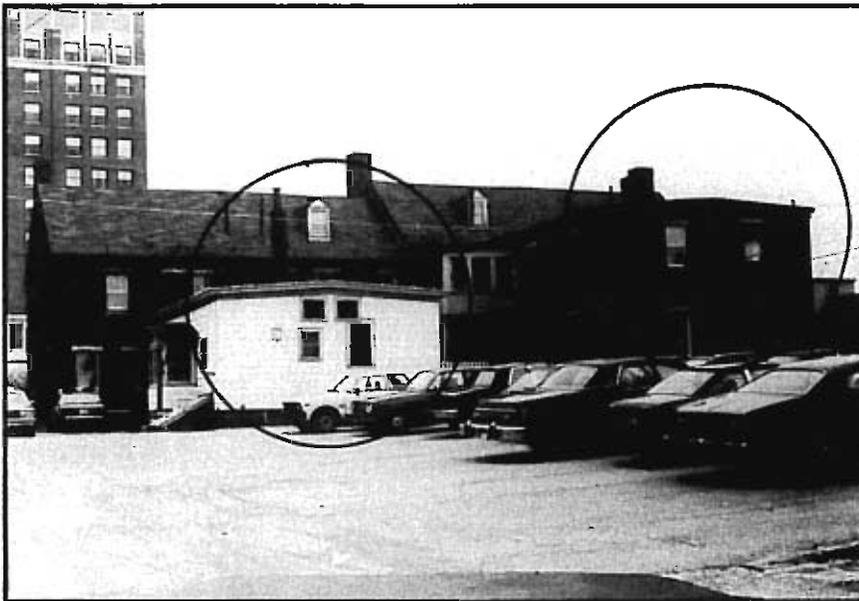
A characteristically low-profile pediment (similar to the entry hood pediment) is found on both brick and frame ells. The photo is of houses on the corner of West Merrimack and Franklin Streets.

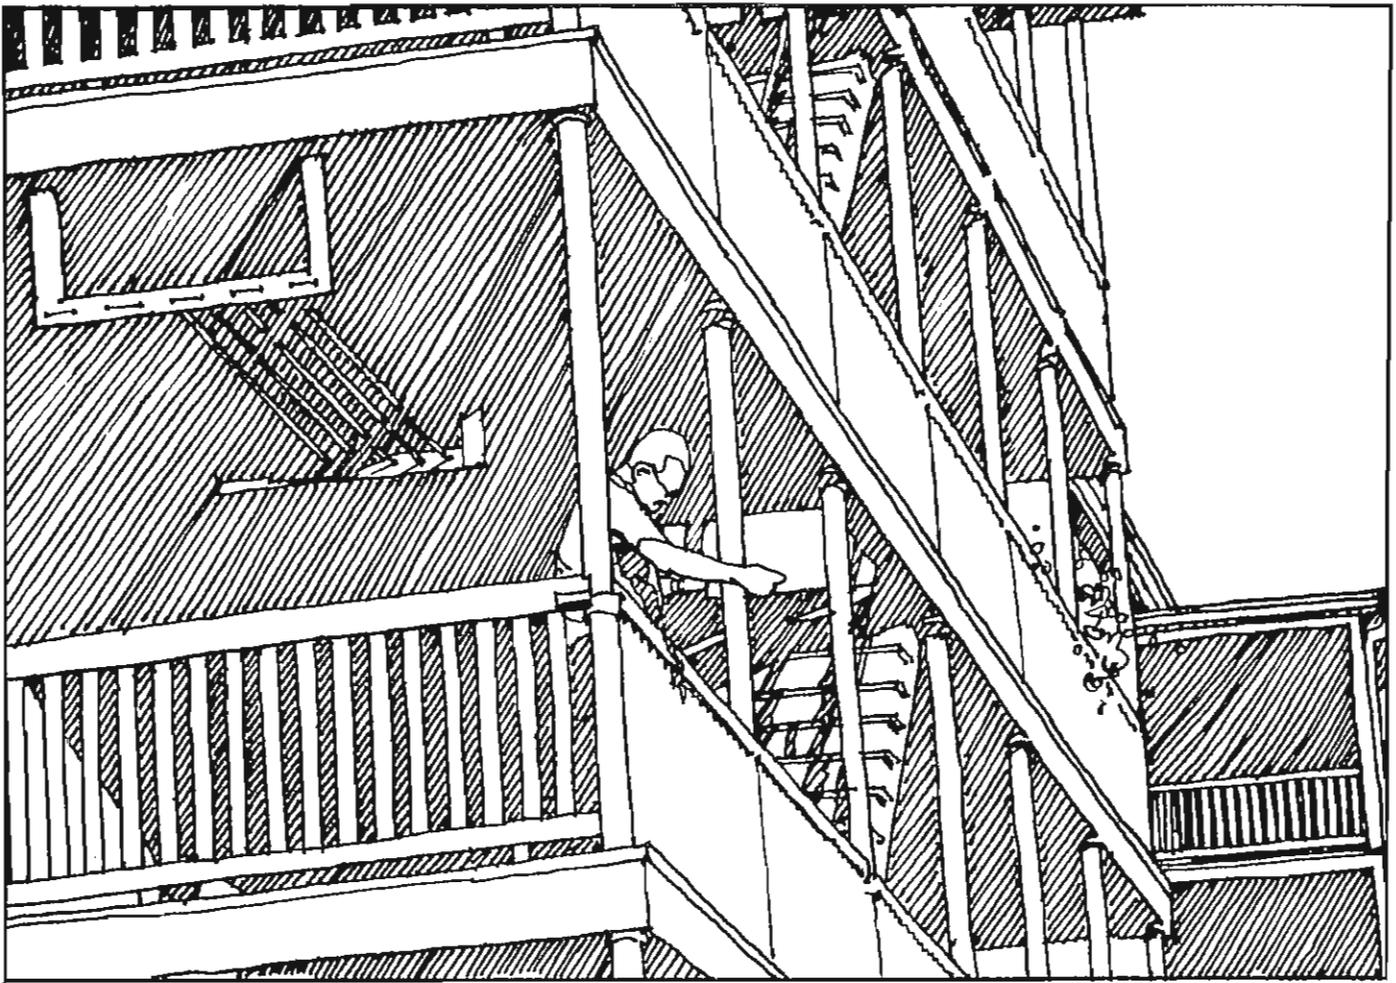
Original wood porches stepped down the hillside in rhythm with the individual buildings. The photo is of the rear of tenements along the north side of West Merrimack Street. When well-maintained, these original wood porches are a utilitarian and handsome component of the Amoskeag.

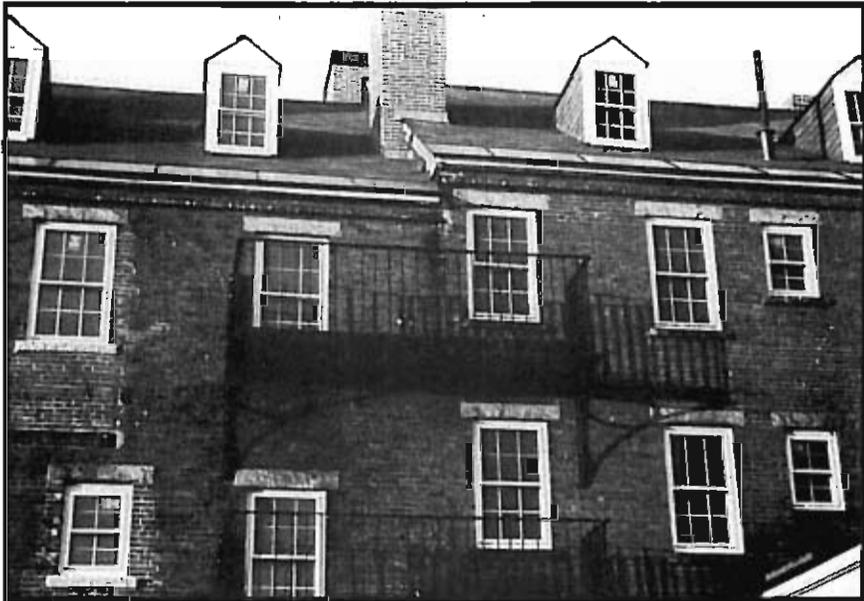
In the top photo notice the pipe rail added to create decks on the roofs of original ells. (On Pleasant Street.) This is a good modern detail.

The photo below shows fire balconies added to rears of tenements on the south side of Middle Street. This is a handsome modern use of the Amoskeag bracket.

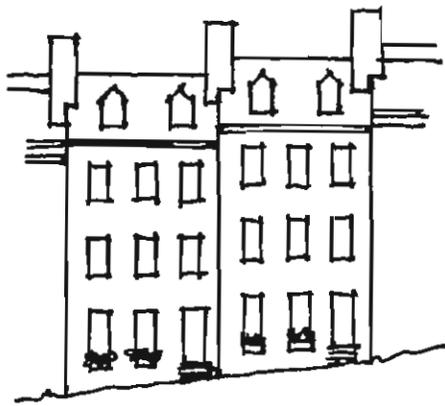
LOCATE ON GROUND  
FLOOR ONLY
